ACCIDENT INVESTIGATION REPORT

AIRCRAFT ACCIDENT No. ACCID01/06

Report on the accident to Airbus A321 during push back at

Macau International Airport on 4th March 2006

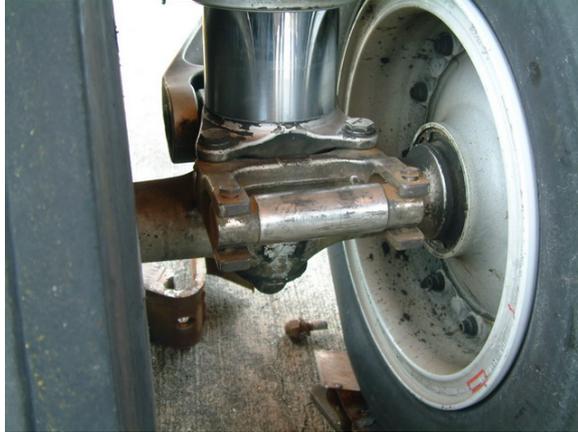
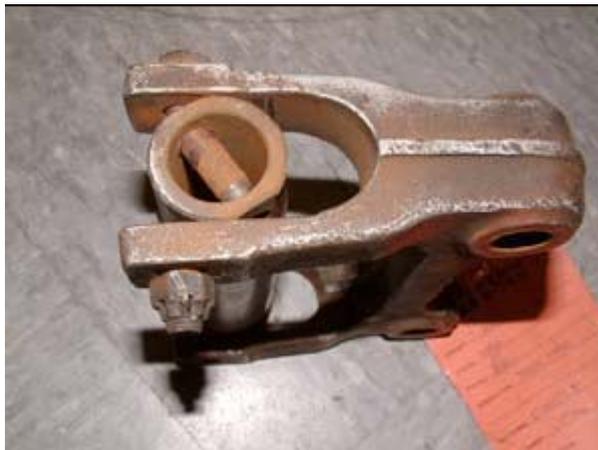
The damage to aircraft is minor. The tow bar attachment fitting at the nose landing gear of the aircraft was damaged due to excessive loading. As a shock absorbent design feature of the fitting, two bolts connecting a tube

in this fitting had broken and the tube was pushed inwards as shown in Figure 1.3.1 and 1.3.2.

After replacement of the fitting, the aircraft was dispatched to service.

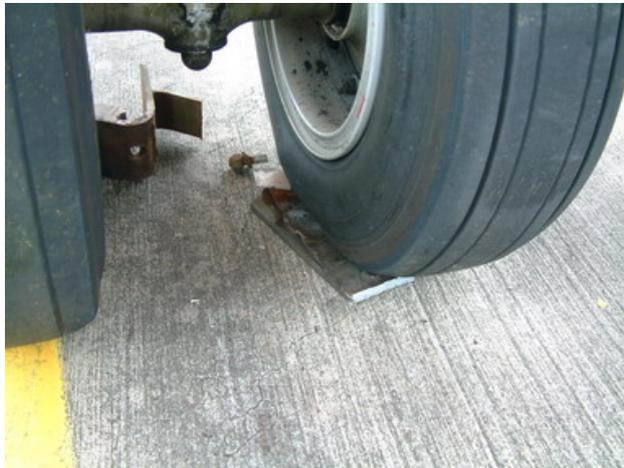
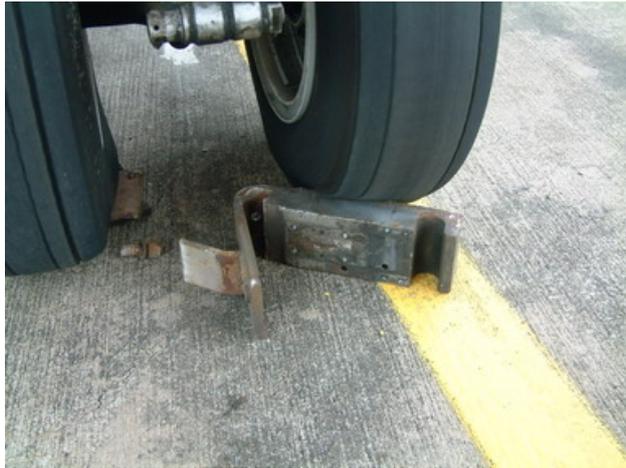
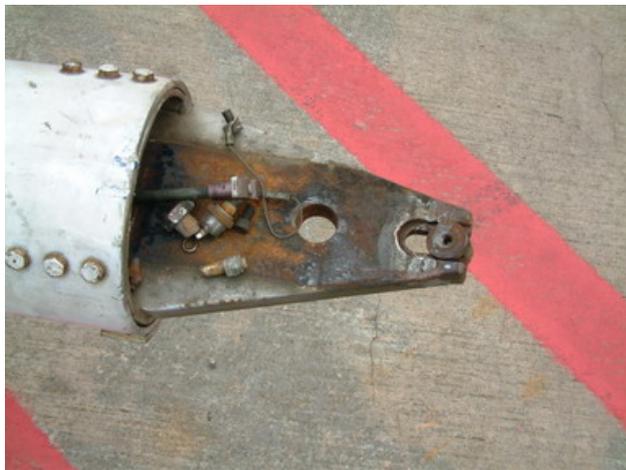
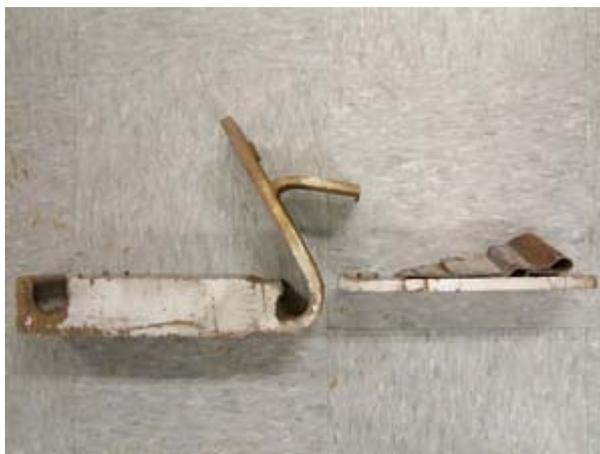
In this accident, all three bolts attaching the towbar head assembly to the head-to-tube connector were broken. As a result, the towbar head assembly liberated from the towbar. The upper plate of the head assembly, broken off from the main body near its welded joint, ended underneath the nose wheel. The lower plate was bent by almost 110° and rested at the back of the nose wheel (as shown in Figure 1.4.3 to 1.4.6).

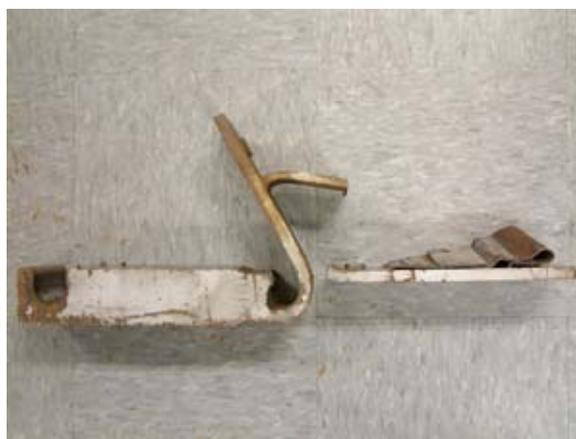
Figure 2-1(a) shows a new head assembly of a towbar. One end of the head assembly consists of a U-channel with a half round shape at the bottom to receive the towbar fitting attached to the nose undercarriage. The other end consists of two parallel plates for connection to the head-to-tube assembly, which in turn connects to the main tube of the towbar with 12 bolts. The connection between the head assembly and the head-to-tube connector is with two shear bolts at either end, and a loosely fitted bolt of about 16 mm in diameter. This will be described in better details in Section 3. Figure 2-1(b) shows the towbar involved in the incident. In comparison with the new towbar head assembly, it can be seen that the top of the two parallel plates is broken off from the main body near its welded joint. Also, the bottom plate was bent by about 110°. Nearly all of the bolts attaching the locking mechanism on the top of the head assembly were broken.

(b) incident towbar head assembly (plate on RHS came off near the top welding position)

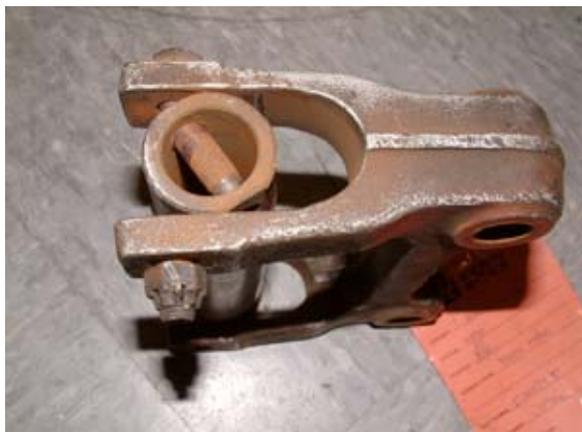
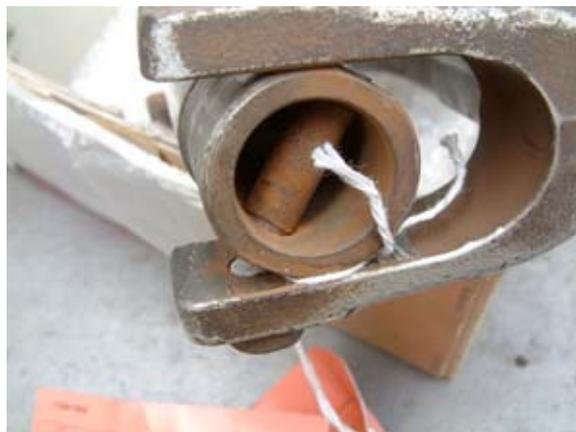
The results on the examination of the damaged head-to-tube connector and head assembly will be provided in a Section 4 of this report and will not be repeated here. During the site visit, the investigator requested to examine the towing fitting attached at the nose undercarriage, and Menzies was able to borrow it from Air Macau for examination. It was then found that both bolts connecting a tube in this fitting had broken, as shown in Figure 3-2. So this part was requested to be on loan from Air Macau for laboratory examination. A section of the bolt shank to nut connection was found, and was very likely from one of the two broken bolts. This was placed at the hole in Figure 3-2(a) for illustration.

Figure 3-2 : Broken bolts attaching the tube in the towing fitting

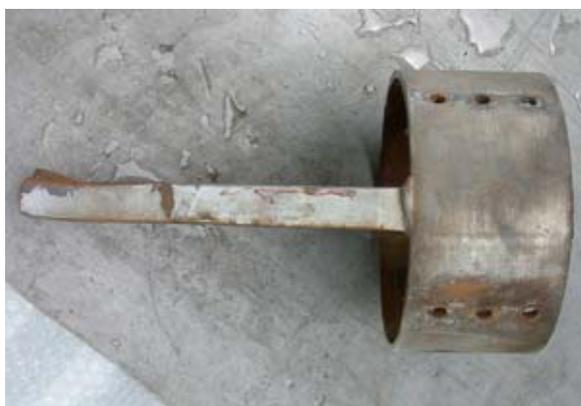
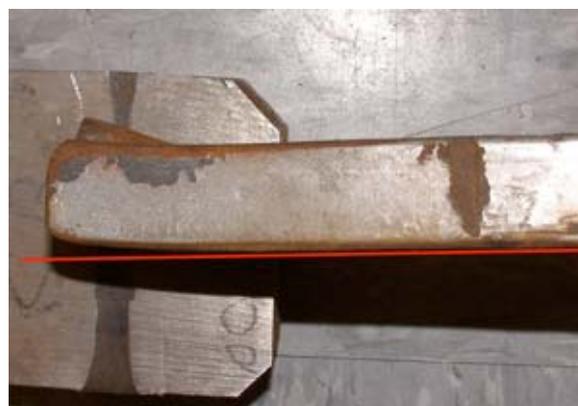
Figure 4-2(a) shows that the tip on the left-hand side of the plate of the head-to-tube connector was bent upwards. This is shown more clearly in Figure 4-2(b), in which a straight red line was drawn to show that the plate was bent. A bushing at this position was also seen to rotate clockwise.

(b) bent tip and rotated bushing

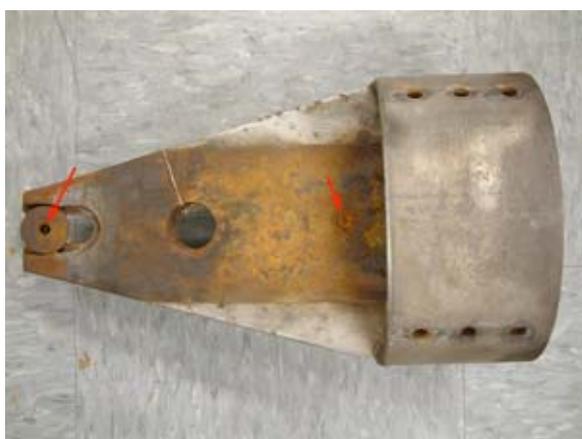
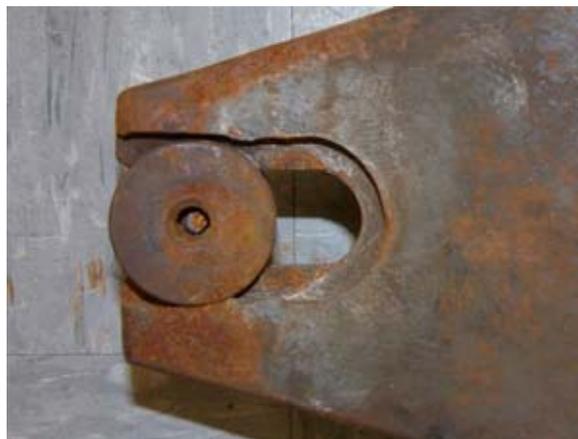
Figure 4-3(a) shows the top view of the head-to-tube connector. The positions for the shear bolts are indicated with red arrows. The remains of the shear bolt on the right-hand side (RHS) can still be seen. Figure 4-3(b) shows the rotated bushing as seen in Figure 4-2(b). The other shear bolt, originally installed through the centre hole of the bushing, was broken and its remains can be seen in this figure. This shear bolt has a smaller diameter than that on the RHS. The middle hole seen in Figure 4-3(a) provides a loose fit for the bolt of about 16 mm diameter, as shown in Figure 3-5. Under close examination, the RHS of the hole wall was found to have dented near the top surface. This shows that a large shear force was applied at this position on the bolt of about 16 mm in diameter.

(b) bushing moved forward

As shown in Figure 4-3(b), the small shear bolt went through the centre of a bushing, which can be slid along a groove. So when the shearing action occurred, the small shear bolt was likely not shear-failed straight away. Instead, the bushing was pushed toward the main tube of the towbar. Due to the interaction between the head-to-tube connector and the bottom plate of the head assembly, as will be explained later, the small shear bolt was later pulled and sheared to the shape as shown in Figures 4-6(a) and 4-6(b). Also, the bent appearance of the shear bolt suggests that a large force existed to shear the bottom plate of the head assembly and the head-to-tube connector apart. As the two parts were not clamped together, the section of the shear bolt originally residing in the bottom plate of the head assembly was pulled out and bent. It was also seen in Figures 4-6(a) and 4-6(b) that large deformation occurred in the groove, as well as a part of the bushing broken off, indicating a large force involved.

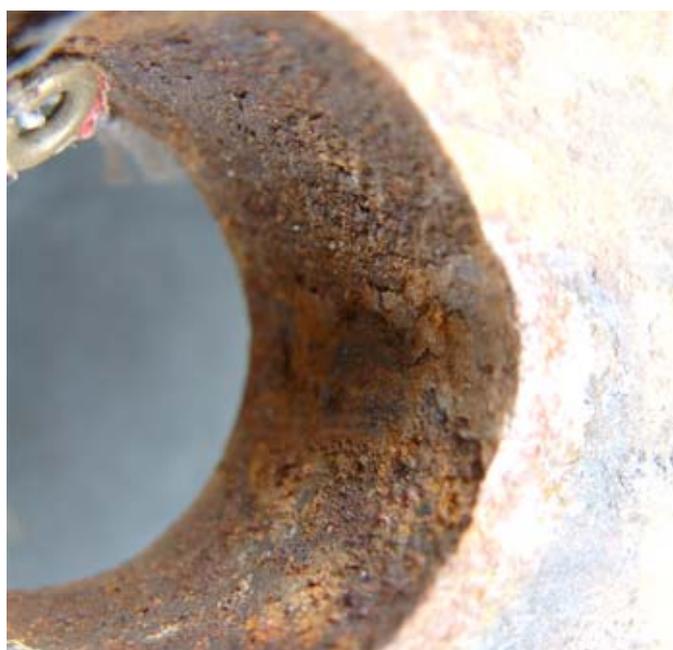
Figure 4-4 : RHS of hole wall dented near top surface

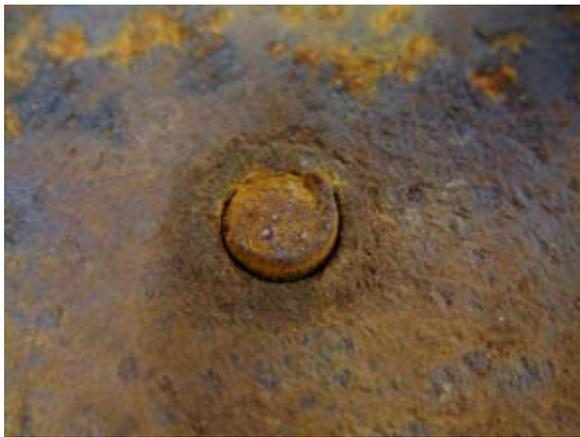
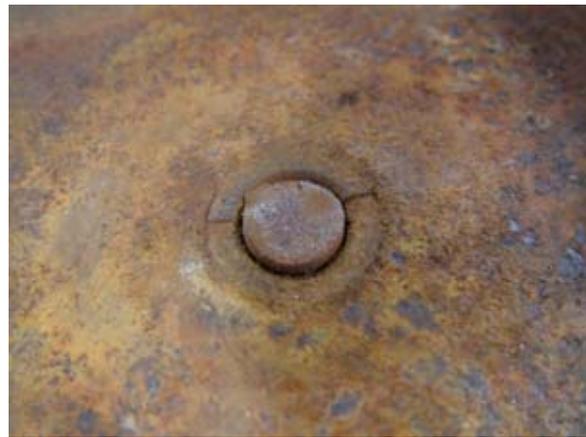
It is clear that the large shear bolt was cleanly sheared off at the top and bottom surface positions of the plate in head-to-tube connector. This is because the fracture surfaces on the top and bottom surfaces are very flat, as shown in Figures 4-5(a) and 4-5(b) respectively.

Figure 4-5 : Large shear bolt fracture surfaces

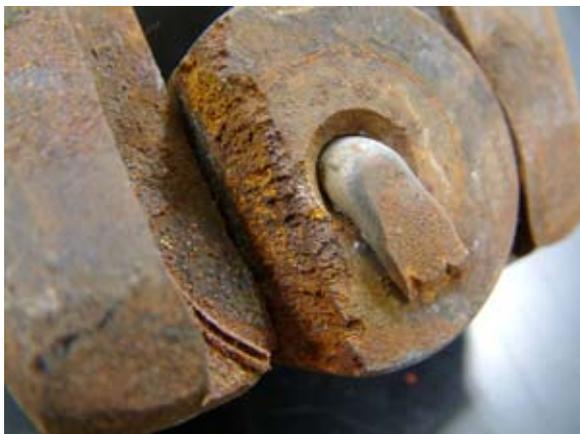
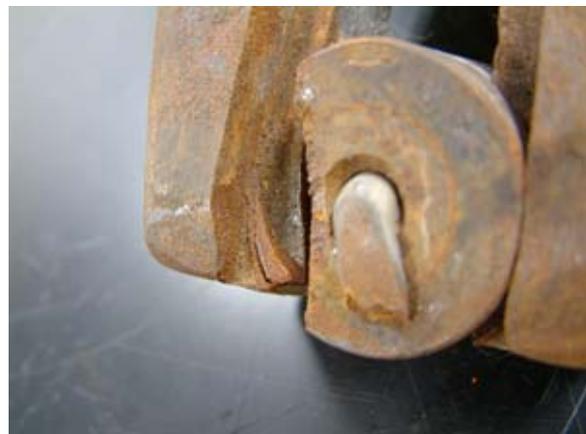
Figure 4-6 : Small shear bolt fracture surfaces

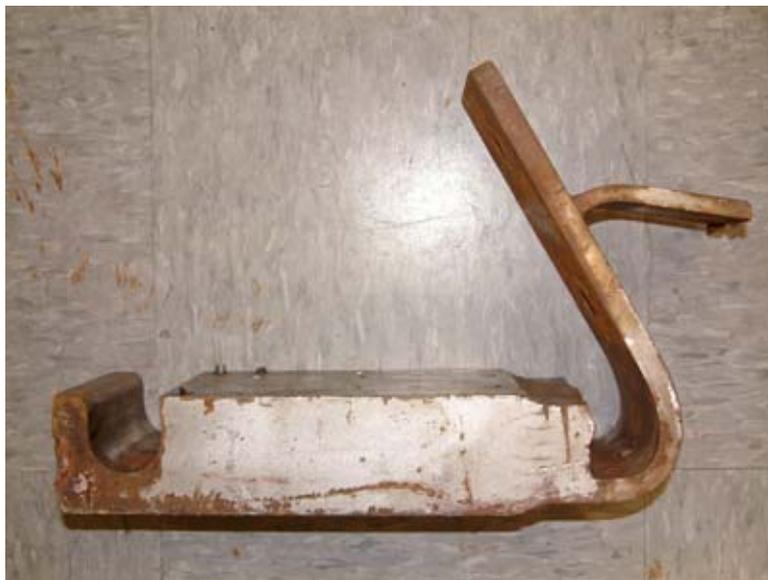
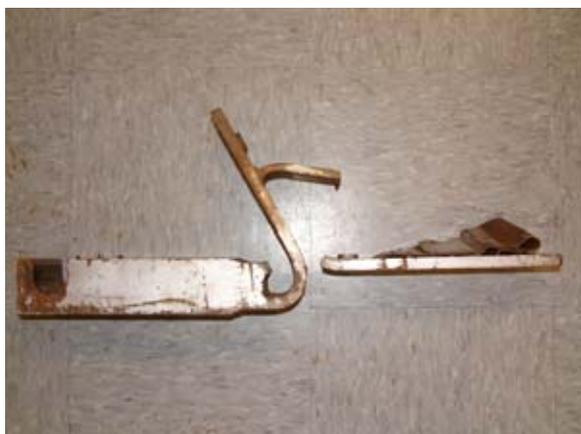
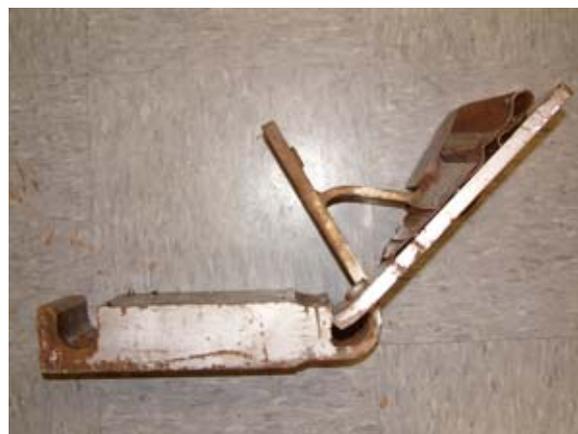
Figure 4-7 shows the damaged head assembly. The top plate, which has the appearance as shown in Figure 4-8(a), broke off. Figure 4-8(b) indicates that the top plate was subjected to bending in the orientation as shown before fracture.

Figure 4-8 : Plates in head assembly broken and bent

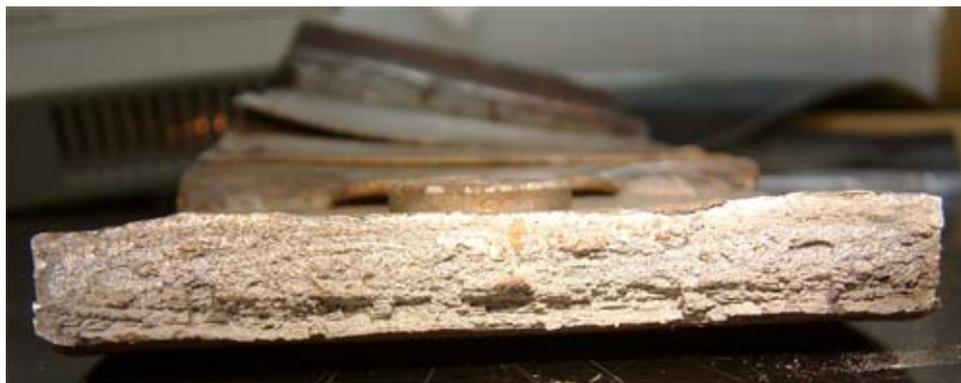
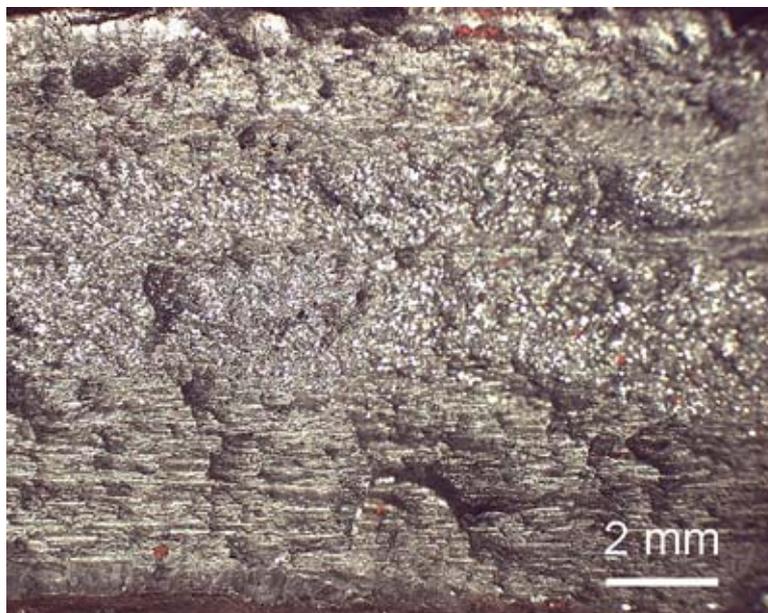
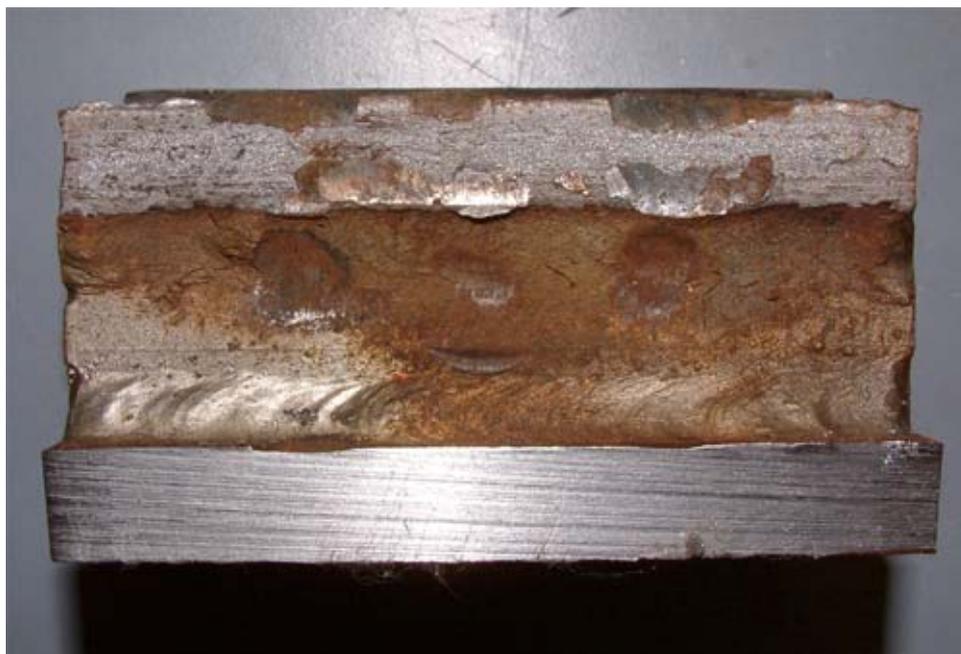
The fracture surface on the broken off top plate is shown in Figure 4-9. It can be seen that the bottom part of the fracture surface contained tensile fracture as well as signs of bending, causing the appearance of layer separation. Figure 4-10 is the other part of the fracture surface, i.e. the one at the head assembly end. It is noted that the bottom plate was sawn off near the welded joint so as to reveal the fracture surface easily. Apart from having a fracture surface similar to that in Figure 4-9, this figure also contains evidence that the middle part, as well as the fracture surface, were subjected to indentation from a certain object. This will be explained later.

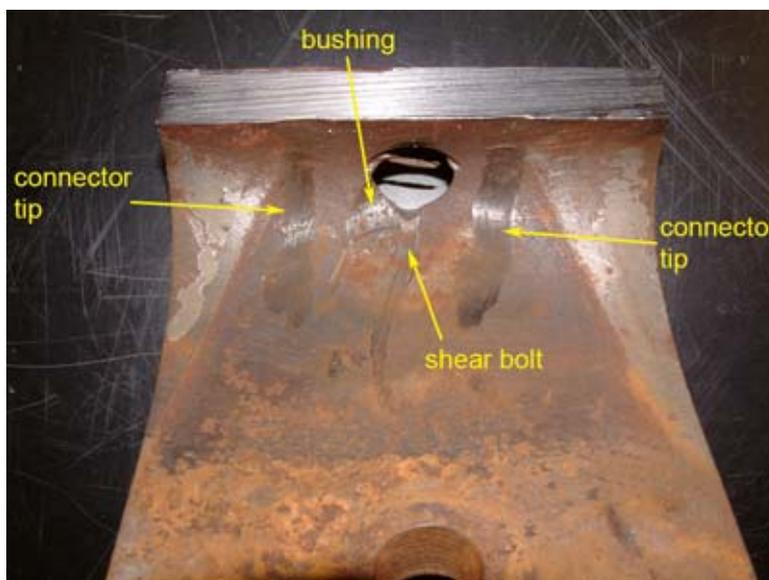
Figure 4-12 shows the curved section of the bottom plate. Some rub marks were found, and were correlated to the parts at the tip section of the head-to-tube connector.

Figure 4-12 : Bent bottom plate with rub marks caused by parts of the head-to-tube connector

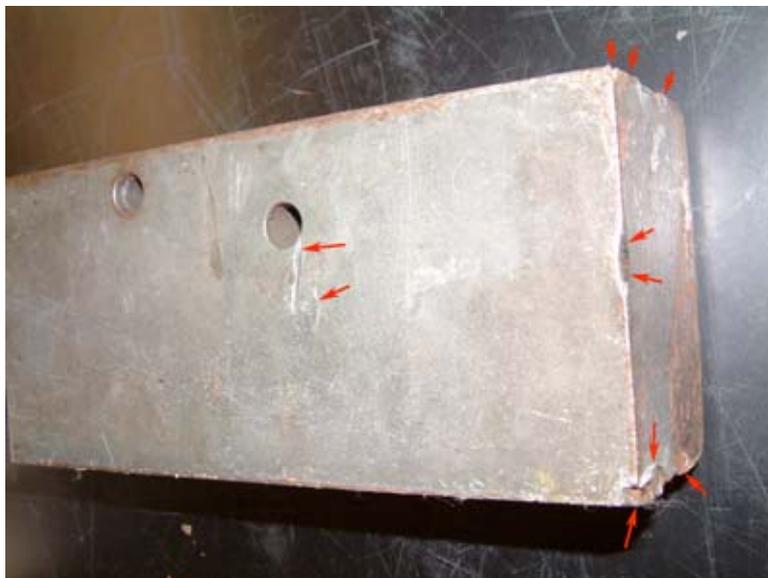
Figure 4-13 shows the bottom surface and end of the head assembly. A number of indentation marks as marked in red arrows were identified.

Figure 4-13 : Bottom surface of the metal block of the head assembly with indentation marks

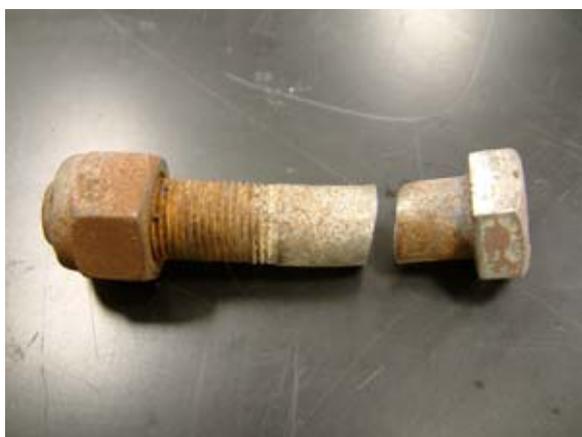
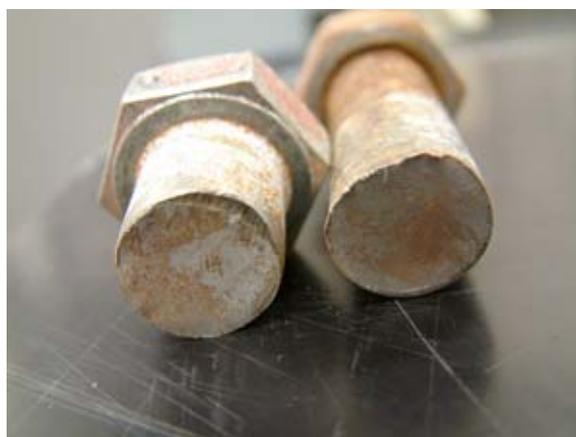
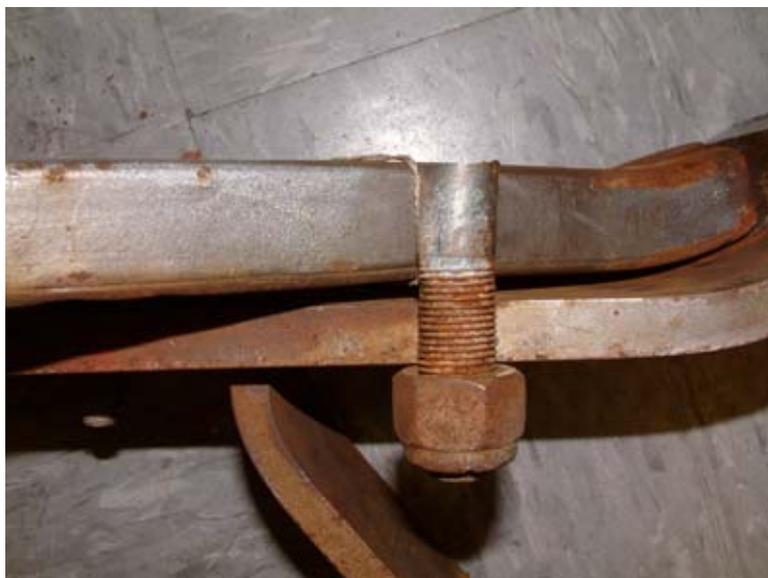
The broken bolts of about 16 mm in diameter were then examined. It can be seen in Figure 4-14 that fracture occurred at the interface position between the top plate of the head assembly and the plate of the head-to-tube connector. The fracture surfaces of this bolt are shown in Figure 4-14. The fracture surface were very flat, and contained evidence that they were shear fractured. Figure 4-15 illustrates that fracture occurred between the top plate and the head-to-tube connector.

Figure 4-15 : Lower part of the broken bolt (about 16 mm dia.) illustrating fracture between top plate and head-to-tube connector

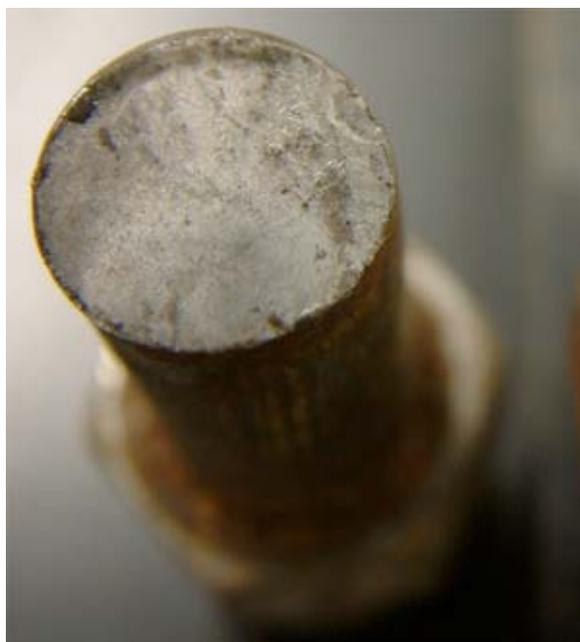
Figure 4-17 shows the fracture surface of the large shear bolt. It can be seen that the fracture surface is very flat.

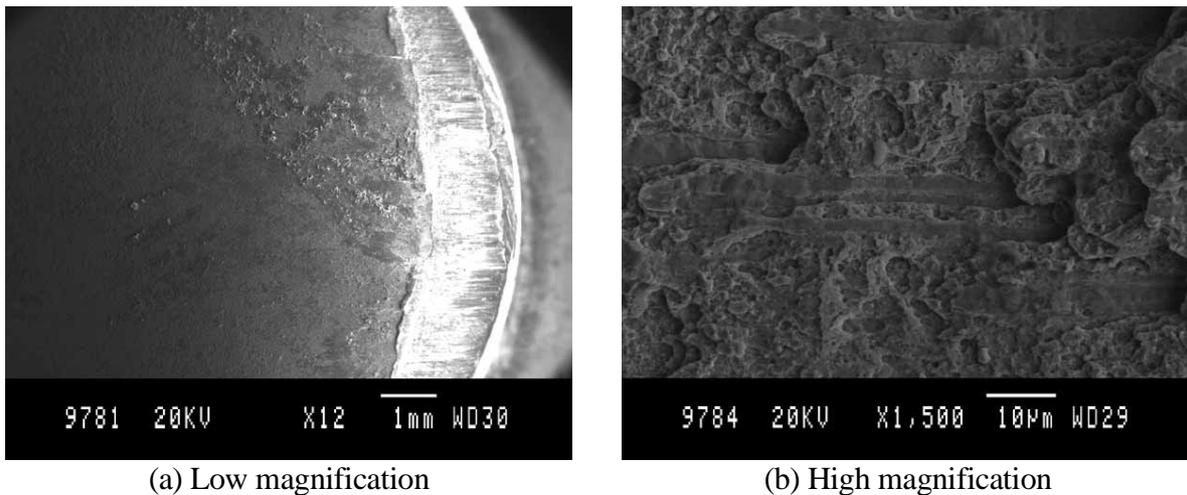
Examination with scanning electron microscope (SEM) was employed to study the bolt material and the welded joints of the head assembly to confirm their integrity. Figure 5-1 shows the fracture surface of the bolt of about 16 mm in diameter (shown in Figure 4-14(b) before). Figure 5-1(a) is a low magnification micrograph, showing the bolt was sheared from left to right. Figure 5-1(b) is a high magnification micrograph, confirming that shearing of the bolt was from left to right.

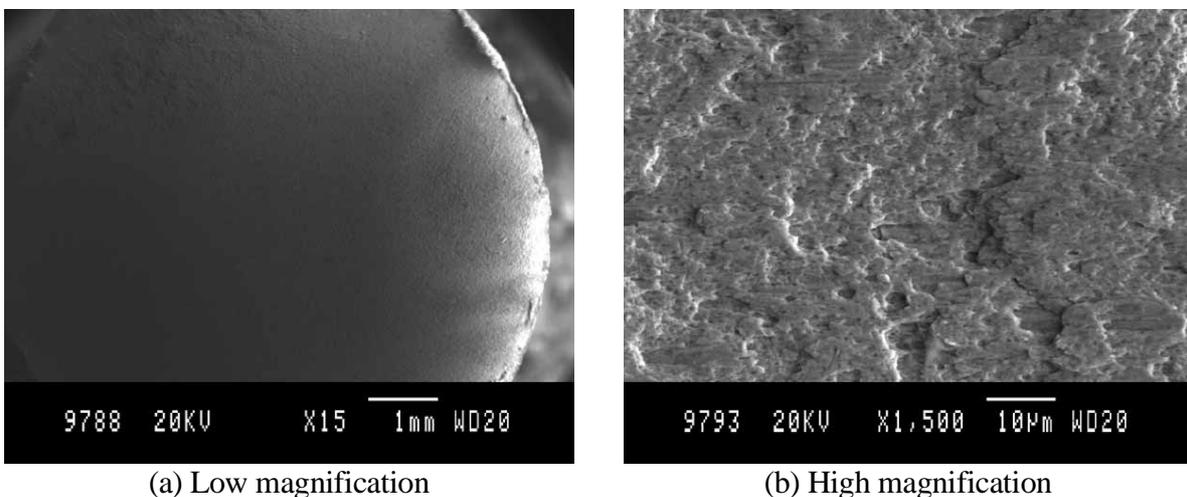
Figure 5-2 shows the fracture surface of the large shear bolt shown in Figure 4-17 before. Figure 5-2(a) is a low magnification micrograph. Figure 5-2(b) is a high magnification micrograph, confirming that shearing of the bolt was from left to right. This material is seen to be softer than that of the bolt in Figure 5-1.

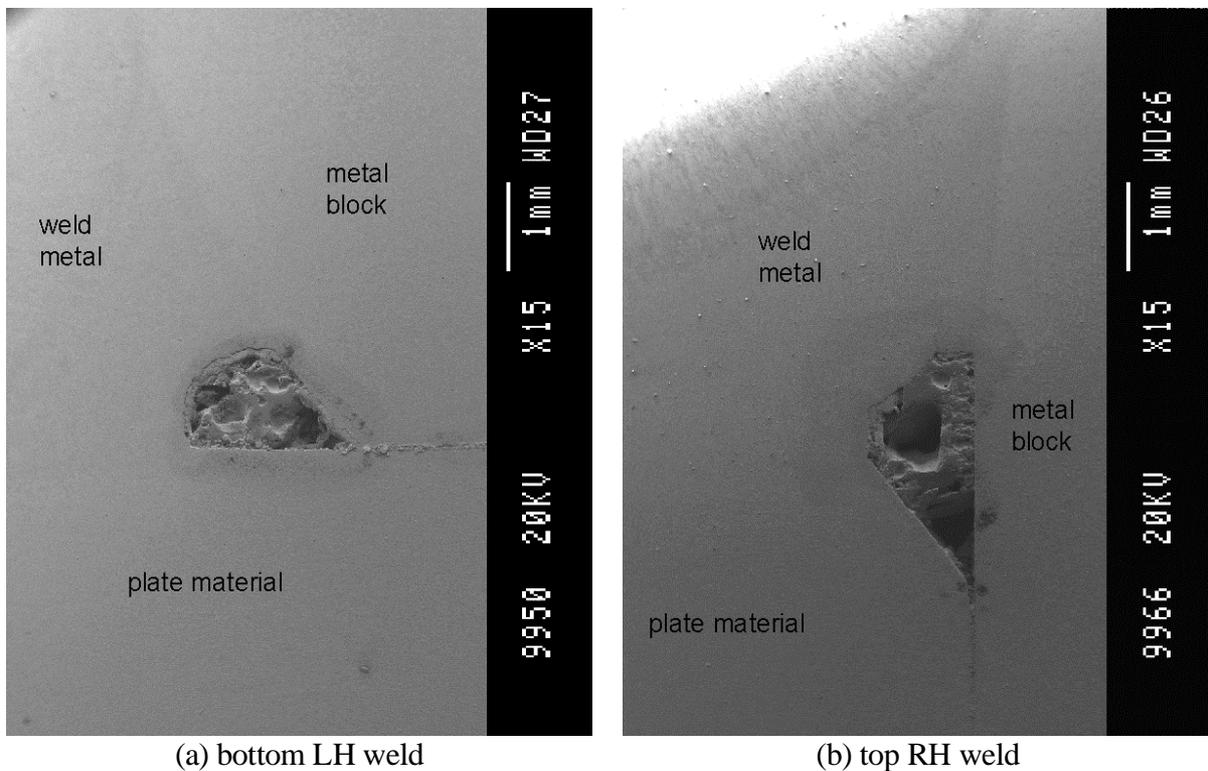
The head assembly is made from a metal block, welded with two horizontal plates. The welded joint of the head assembly was first sectioned at an appropriate location, as shown in Figure 5-3(a). Grinding, polishing and etching were carried out as shown in Figure 5-3(b), so as to reveal the microstructure. Figures 5-4(a) and 5-4(b) show typical microstructures at welded joints. They both show good weld interfaces between weld metal and metal block or plate.

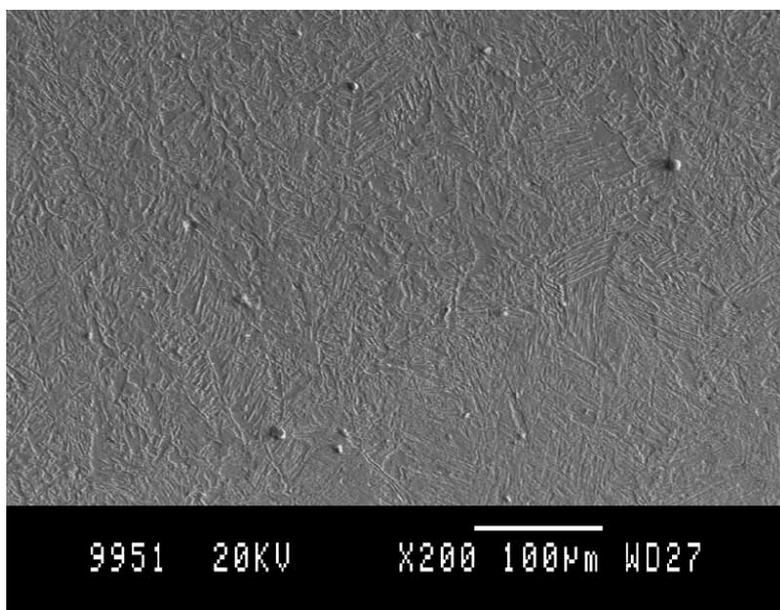
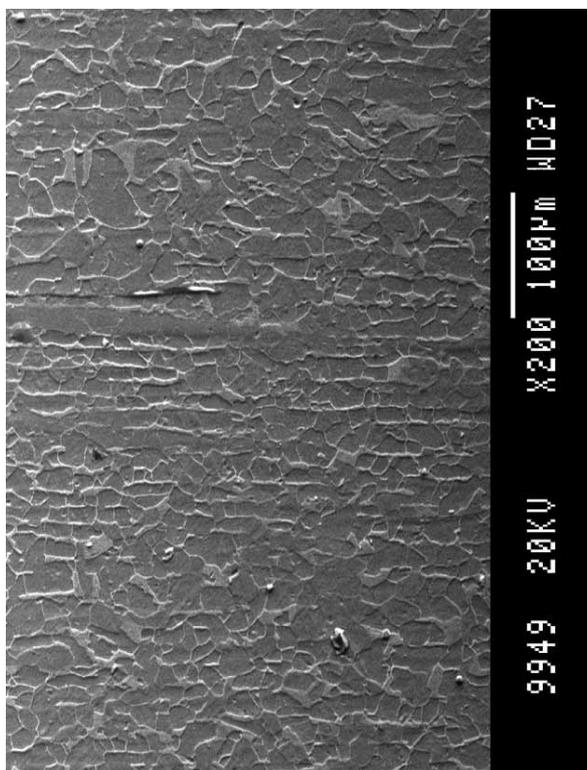
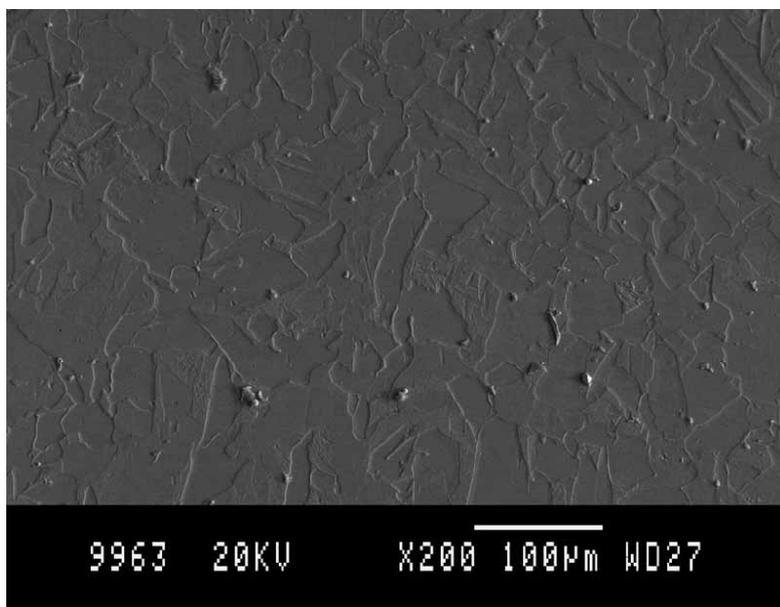
Figures 5-5, 5-6 and 5-7 show the microstructures of the weld metal, block metal and plate metal respectively. It can be seen that the plate material is relatively soft. However, the microstructure of the three types of material are in good order.

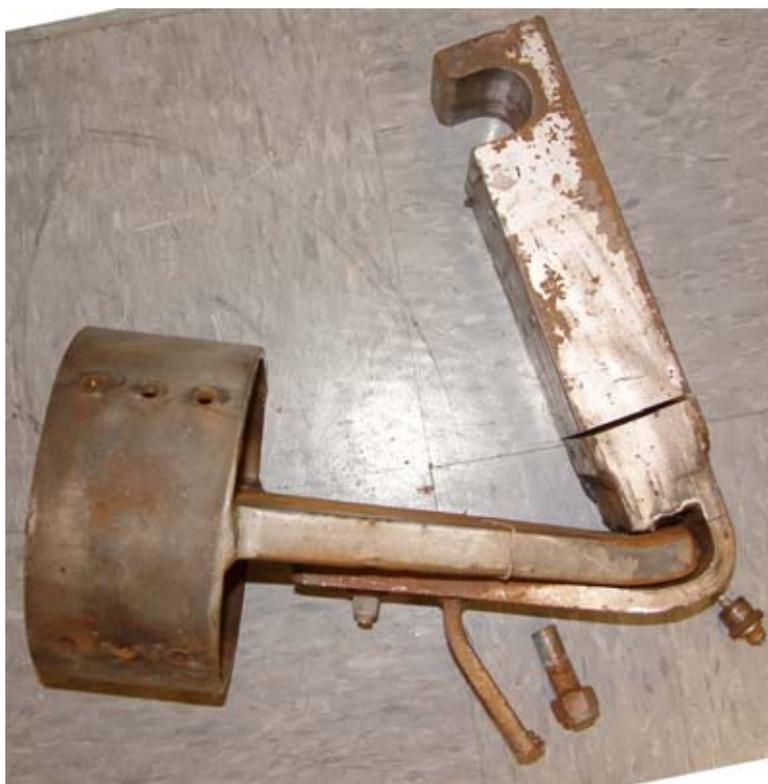
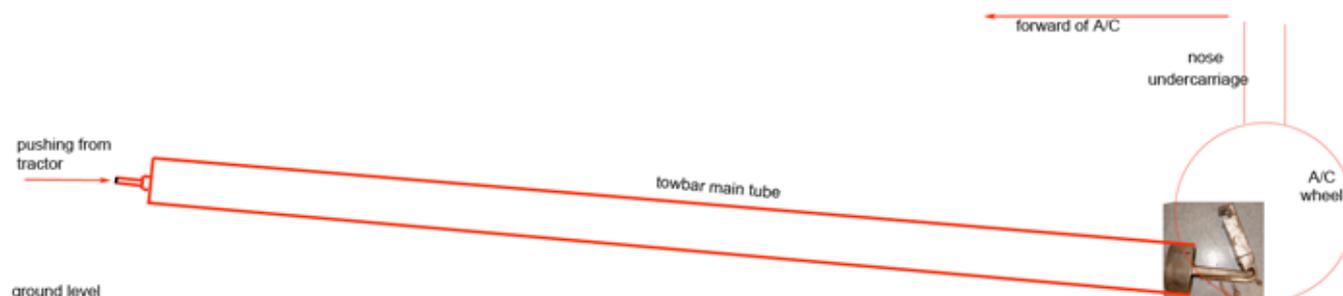
According to the information given to the investigator, the pushback was carried out as normal for about 5 m, then suddenly the towbar head broke. The above examinations have indicated how the parts in the towbar head assembly were related to each other during the incident. Figure 7-1 is a mock-up of the final positions of the relevant parts when the towbar came to a rest. Then, by further relating the head assembly with the main remaining parts of the towbar, the towbar position in relation to the undercarriage can be determined, and is shown in Figure 7-2.

- a. The large shear bolt was shear fractured.
- b. Due to the weight distribution of the towbar and the loss of the large shear bolt, an eccentricity, say 10 mm, was set up, leading to bending stress on the plates due to the applied pushing force from the tractor.
- c. The top plate bent. When bending increased, the bolt of about 16 mm in diameter was sheared. The bending action continued very fast with the plates going down toward the ground. That is, the main tube rotated.
- d. The top plate broke off when it reached the maximum stress bearable at the root of the plate. Bending continued with the bottom plate, until it was folded into the shape as shown in Figure 7-1.
