Aviation Occurrence Investigation Preliminary Report

INCID/02/2018

Aircraft Took-off from Engaged Runway

Macau International Airport

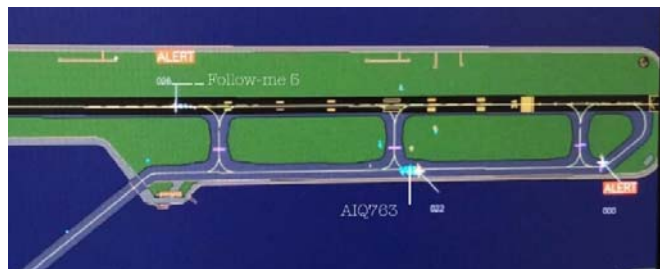
At 06:34, tower issued the departure clearance to flight AIQ763 / FD763, at this point, follow-me 5 was still in runway 34 doing inspection and visual alerts in amber for follow-me 5 was indicated on the Surface Movement Radar (SMR).

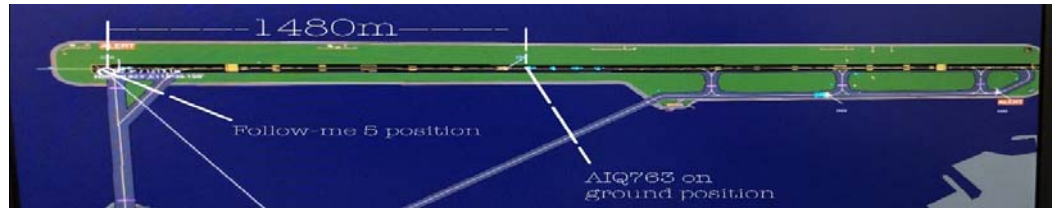
Follow-me 5 vacated runway at 06:36 and flight AIQ763 / FD763 airborne at around 06:37. According to the positions of aircraft and vehicle indicated on the SMR, the estimated nearest distance between both moving objects was about 1480 metres or 0.8 nautical miles.
