Aviation Occurrence Investigation

Final Report

INCID/01/2018

Aircraft Damage Caused by Hard Landing

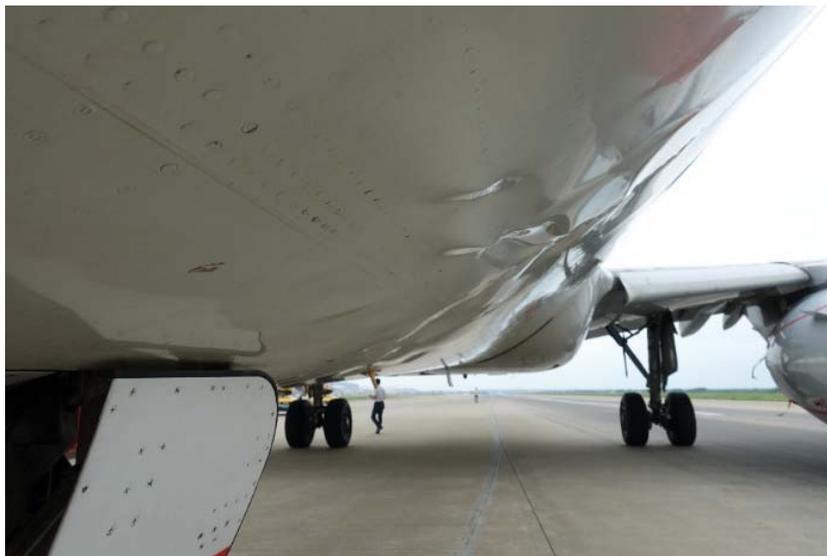
1. Deformation at frame 17 – frame 24, stringer 30 right hand – right hand lower stringer.
2. Deformation at frame 18 – frame 24, lower right hand stringer trace – lower left hand stringer trace.
3. Deformation at frame 15 – frame 24, stringer 30 left hand – left hand lower stringer.
4. Deformation at frame 20 and cabin floor beam.

Figure 1: Aircraft fuselage damage

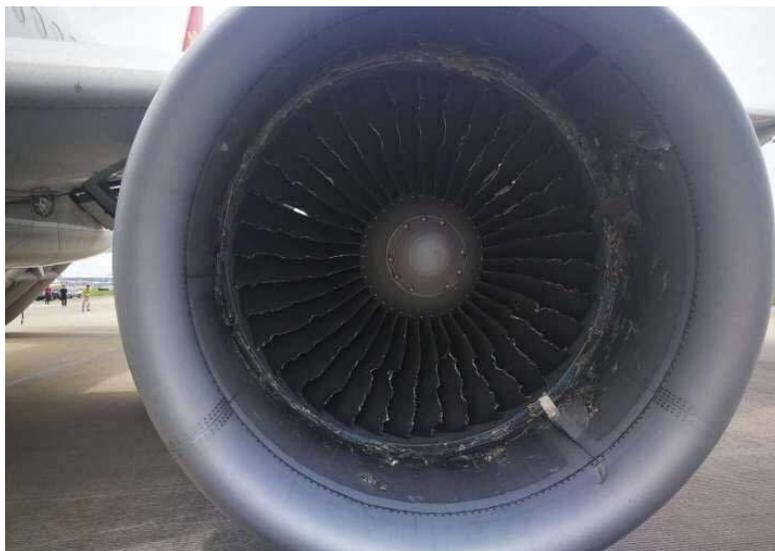
1. All 36 fan blades damaged.
2. 2 penetration damages in fan case.
3. Severe damage at low-pressure compressor (LPC) and high-pressure compressor (HPC) blades due to foreign object debris.
4. Combustor, high-pressure turbine (HPT) and low-pressure turbine (LPT) are attached with melted metal.
5. Penetration damage at leading edge of inner fan cowl.
6. Severe damage at acoustic panels.
7. Nicks and dents at thrust reversers.
8. 3 Nicks at pylon movable fairing.

Figure 2: Engine #1 (left engine) damage

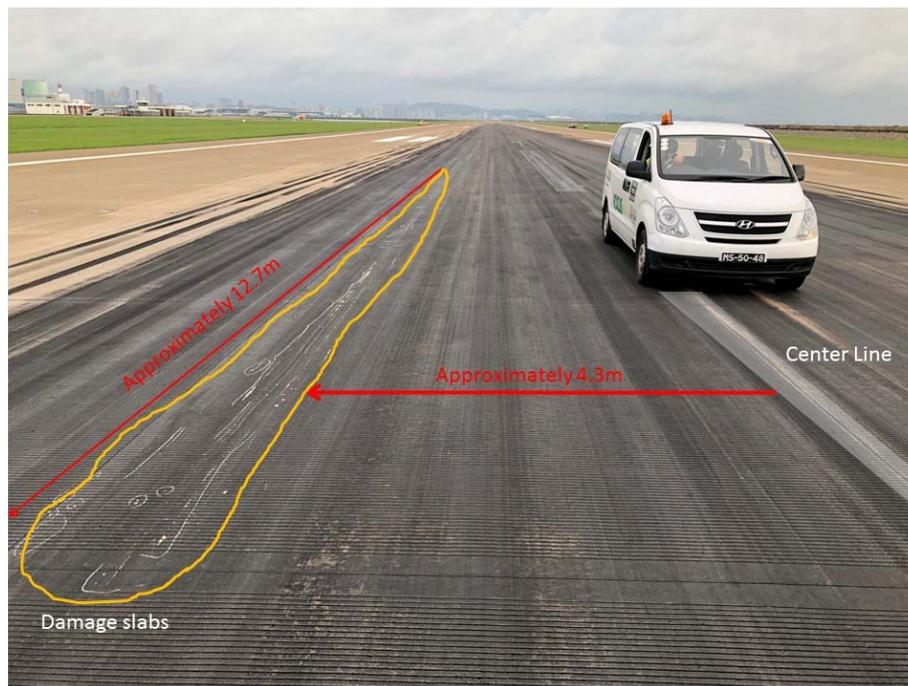
After the hard landing in Macao, some runway slabs were damaged with scratch of approximately 12.7 metres long.

Figure 3: Runway slabs damage at Macau International Airport

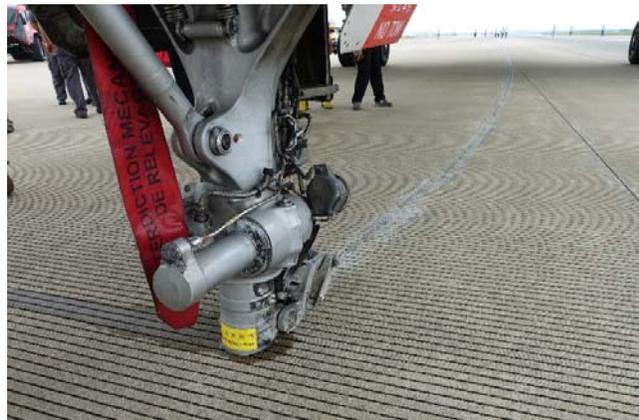
After the aircraft landed at Shenzhen, some runway slabs were damaged with scratch of approximately 395 metres long. 3 runway lights were damaged.

Figure 4: Runway slabs damage at Shenzhen Bao'an International Airport

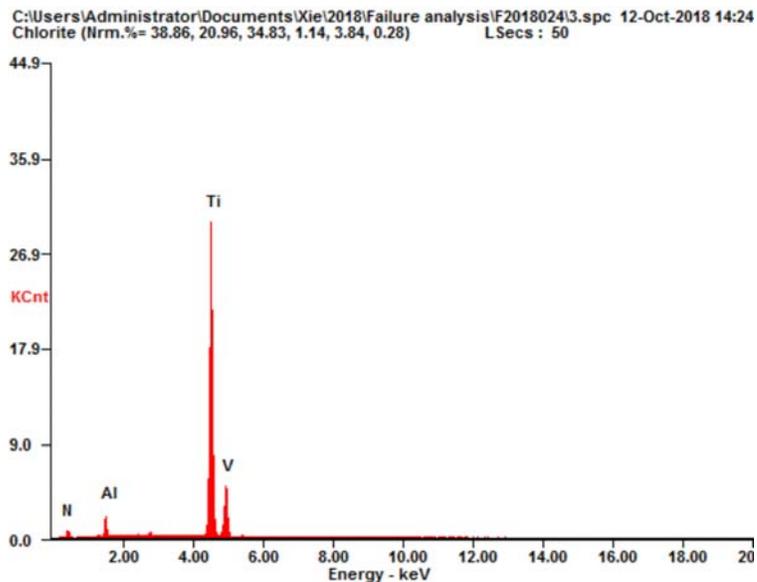
Figure 5: Spectral analysis on the 2 dark grey color debris found in Engine #1

Spectral analysis were conducted to the debris found in the left engine, 2 pieces

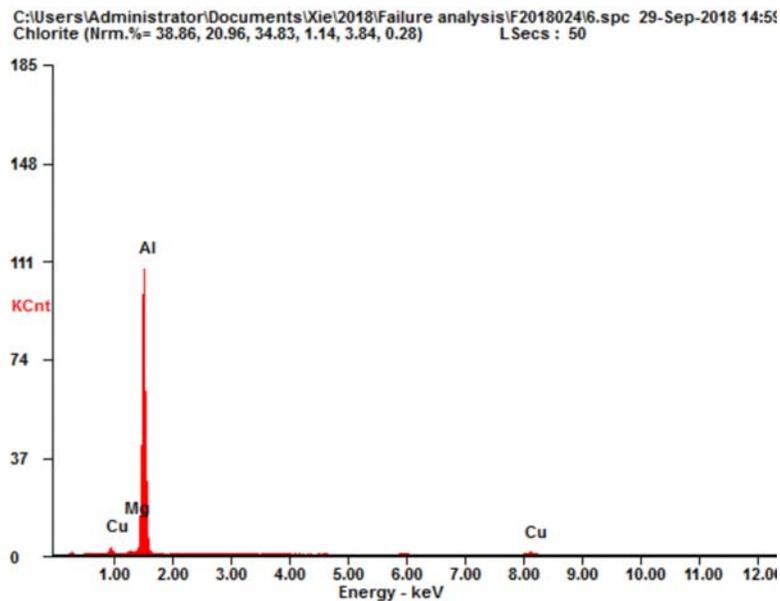
Figure 6: Spectral analysis on the debris sample found in Engine #1

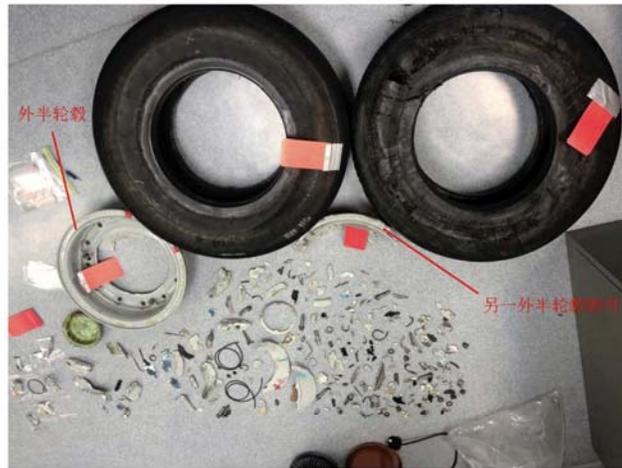
图 1 为澳门机场跑道上收集到的飞机损伤部件形貌，包括 2 个前轮轮胎，1 个较完整的半轮毂，该半轮毂中心毂分离，中心毂周围的辐板缺失，轮毂圆筒外形结构基本完好。另有一段约四分之一周长的半轮毂圆筒断裂件。剩余的断裂部件尺寸较小，其中很多是表面涂有灰漆的轮毂断裂碎块。还有多个断裂的轮毂螺栓，以及一些机轮轴承部件如滚棒，卡圈等。2 个前轮轮胎中一个轮胎胎侧多处破裂，如图 2 所示，另一个轮胎较为完好。

图1、澳门机场跑道上收集到的飞机损伤部件形貌

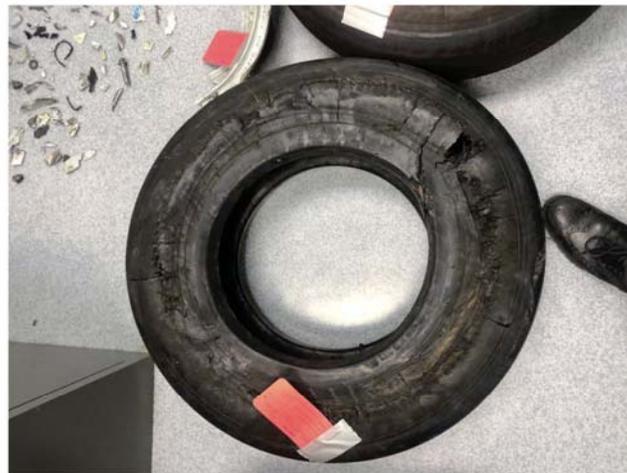
两个前轮中，一个前轮轮胎侧多处爆裂，另一个前轮轮胎较为完好；一个前轮轮毂的外半轮毂断裂成多个碎块，其中心毂沿轴向和周向都发生了断裂，而另一个前轮轮毂的外半轮毂较为完整。这表明其中一个机轮承受了很大的撞击力，导致轮胎爆裂，外半轮毂包括中心毂断裂成多个碎块，部分轴承滚棒脱落；该机轮内半轮毂中心毂周围的辐板断裂，中心毂从轮毂分离。该机轮外半轮毂断裂为碎块而内半轮毂较为完整，表明飞机前轮接地时飞机向一侧有较大的倾斜，使得巨大的撞击力主要作用在该机轮的外半轮毂上。该机轮轮胎爆裂时轮胎高压气流使得部分轮毂碎块喷射入发动机进气道中。另一个前轮也承受了很大的撞击力，但其撞击力明显小于之前发生爆裂的前轮，导致内、外半轮毂中心毂周围的辐板断裂，内、外半轮毂中心毂均从轮毂分离。2 个机轮轮毂的 3 个半轮毂与其中心毂发生分离后（另一

图2、一个前轮轮胎侧破裂形貌

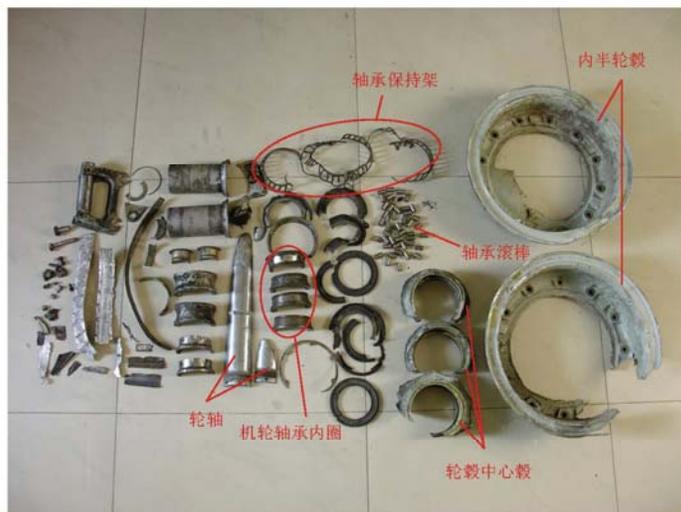
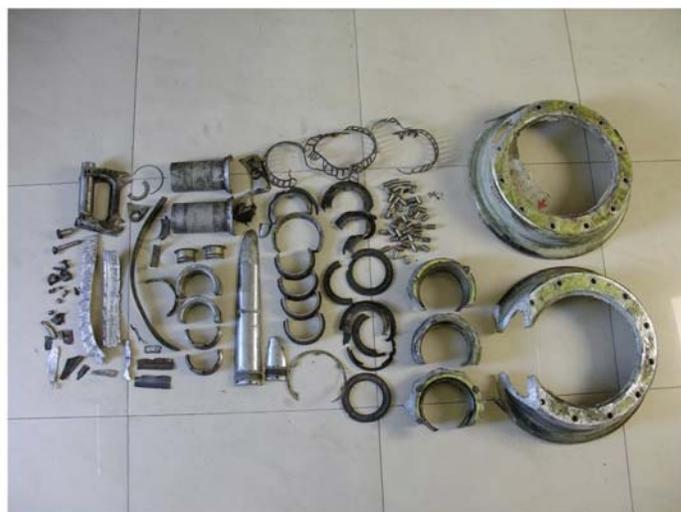
图 3 和图 4 为深圳机场跑道上收集到的飞机损伤部件形貌，包括：
1) 2 个半轮毂，这 2 个半轮毂的中心毂分离，几乎全部辐板缺失，一个轮毂圆筒因磨损导致圆周局部磨穿，另一个轮毂圆筒因严重磨损导致轮毂圆筒八分之一圆周缺失。
2) 3 个脱落的较完整轮毂中心毂，

其中 2 个中心毂中带有轴承外圈，这 3 个脱落的轮毂中心毂因发生了严重的局部磨损约 30%圆周缺失。3) 4 个机轮轴承内圈，因严重局部磨损约 30%圆周缺失。4) 1 个机轮轴承外圈，因发生严重的局部磨损约 30%圆周缺失。5) 40 余粒机轮轴承滚棒。6) 4 个机轮轴承保持架残件，均发生断裂和变形。7) 多个机轮轴承封严和 1 个机轮轴承卡圈。8) 一大段和一小段前机轮轮轴。9) 2 个磨损到一半周长的机轮轴承卡死螺母。10) 一些前轮轴套筒损伤件和螺栓断裂件

图3、深圳机场跑道上收集到的飞机损伤部件形貌

图4、深圳机场跑道上收集到的飞机损伤部件形貌（部分零件角度不同）

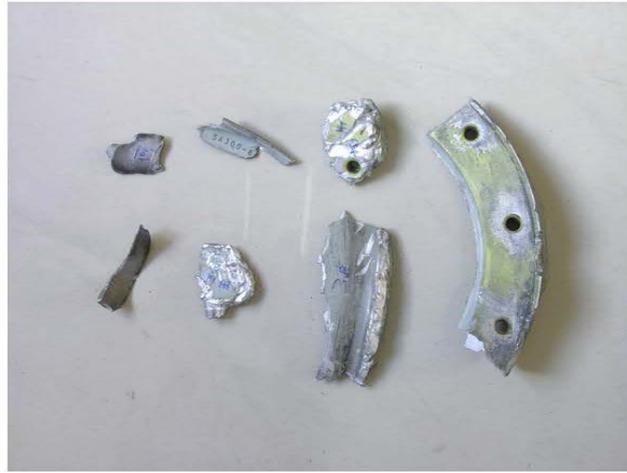
图 5 为发动机中收集到的断裂件，包括一段长 250mm 的弧形带螺栓孔的宽厚断裂结构件，另有 2 块带弧形的薄壁碎块和 2 块团块状的碎块，这些断裂件断面呈银灰色，表面涂有灰色或浅绿色油漆，密度较低。这些断裂件的结构形状、颜色和表面涂漆特征与轮毂相符，应为轮毂的断裂碎块。另外 2 个碎块均为黑灰暗薄片状，与轮毂材料特性不符。

8) 能谱成分测试表明发动机中收集到的2片黑灰色薄片材料成分与美国Ti-6Al-4V钛合金成分相近,应为发动机压气机叶片。发动机中收集到的其它碎块材料与美国2017或2024铝合金成分相近,为轮毂断裂件。

图 5、发动机中收集到的断裂部件形貌

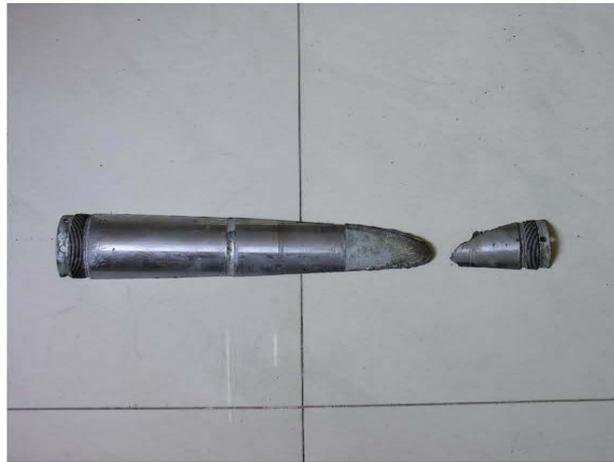
前轮轮轴损伤形貌如图 6 所示，2 段轮轴分别为左、右前轮轮轴，一段长 384mm，该段轮轴端头剩余尺寸最大，约剩余三分之一圆周；另一段长 108mm，该段轮轴也是端头剩余尺寸最大，约剩余六分之一圆周。

7) 左、右前轮轮轴剩余长度差别巨大,表明飞机在深圳机场降落滑跑时向一侧有较大倾斜

图 6、前轮轴轴损伤形貌

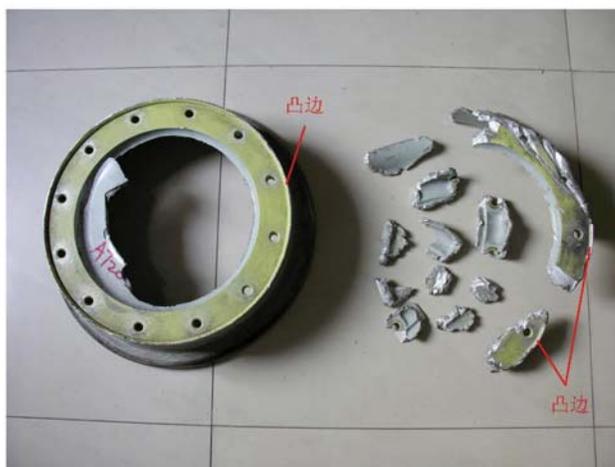
澳门机场跑道收集到的基本完整半轮毂和半轮毂筒身断裂件形貌如图 7 所示，发动机中收集到的带螺栓孔的轮毂断裂碎块放大形貌如图 8 所示，这些半轮毂或半轮毂断裂件的 O 形密封圈处有凸边的结构，由此可判定澳门机场跑道收集到的基本完整半轮毂和半轮毂断裂件（包括发动机中找到的半轮毂断裂件）为外半轮毂。深圳机场跑

图 7、澳门机场跑道收集到的基本完整半轮毂和全部的半轮毂筒身断裂件形貌

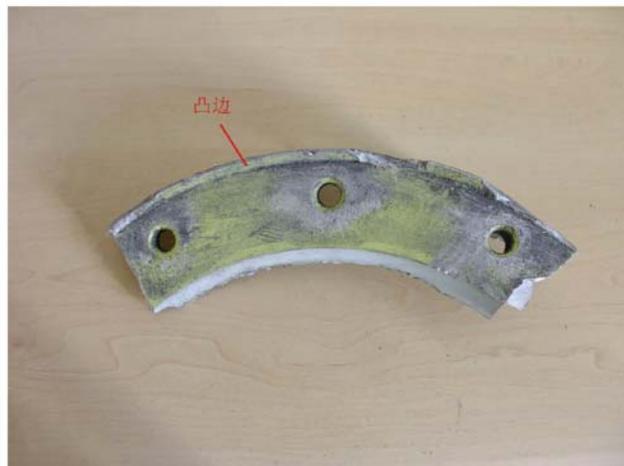
图 8、发动机中收集到的轮毂断裂碎块放大形貌

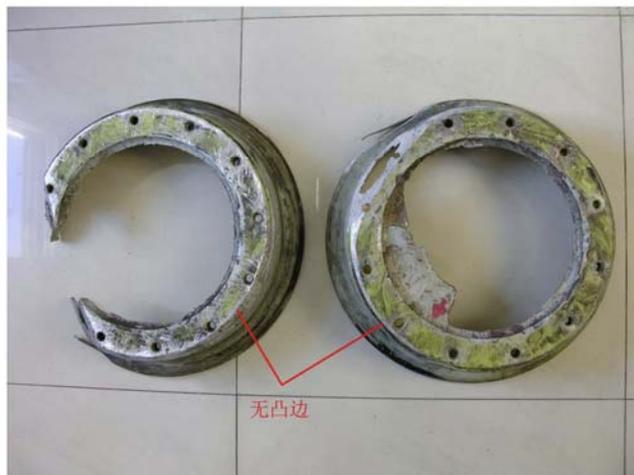
图 9、深圳机场跑道上收集到的两个半内轮毂放大形貌

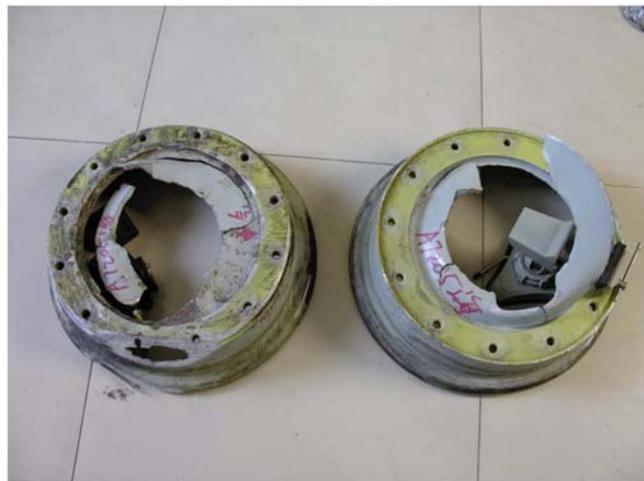
图 10、序列号为 A7205 的内、外半轮毂及确定属于这 2 个轮毂的辐板碎块形貌

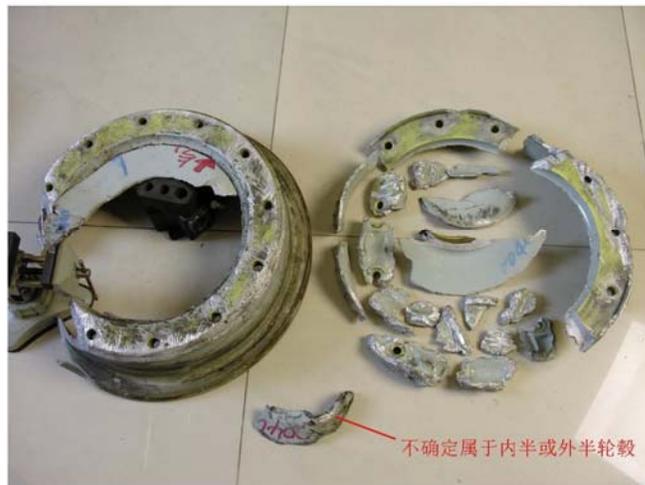
图 11、序列号为 A0040 的内、外半轮毂及确定属于这 2 个轮毂的辐板碎片形貌

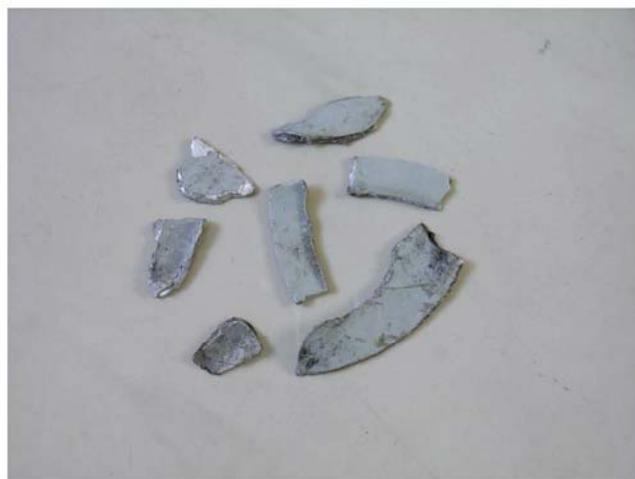
图 12、不能确定属于上述哪个轮毂的轮毂辐板碎片形貌

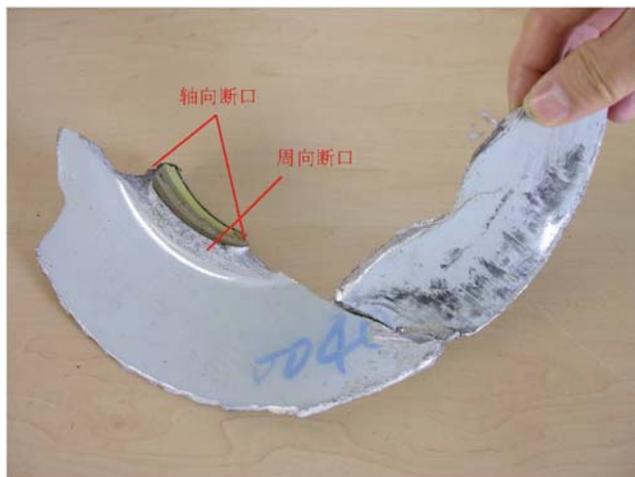
2 个前轮轮毂，一个序列号为 A7205，另一个序列号为 A0040。根据轮毂和辐板碎块断口开状及断裂件上的手写文字的匹配性可确定一些轮毂辐板碎块属于某个特定的半轮毂。序列号为 A7205 的内、外半轮毂及确定属于这 2 个轮毂的辐板碎块形貌如图 10 所示。序列号为 A0040 的内、外半轮毂及确定属于这 2 个轮毂的辐板碎块形貌如图 11 所示。不能确定属于 A7205 或 A0040 轮毂的轮毂辐板碎块形貌如图 12 所示。序列号为 A0040 的外半轮毂有一片辐板碎块带有部分中心毂圆筒，如图 13 所示，该碎块中心毂圆筒部分长度为中心毂圆筒长度的六分之一，中心毂圆筒不仅沿周向断裂，而且沿周向也发生了断裂。

图 13、序列号为 A0040 的外半轮毂的一片带有部分中心毂圆筒的辐板碎块形貌

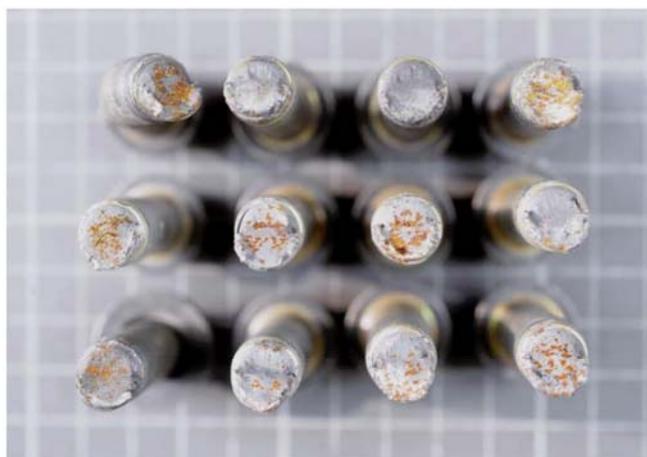
图 14、收集到的 12 根轮毂螺栓断口形貌

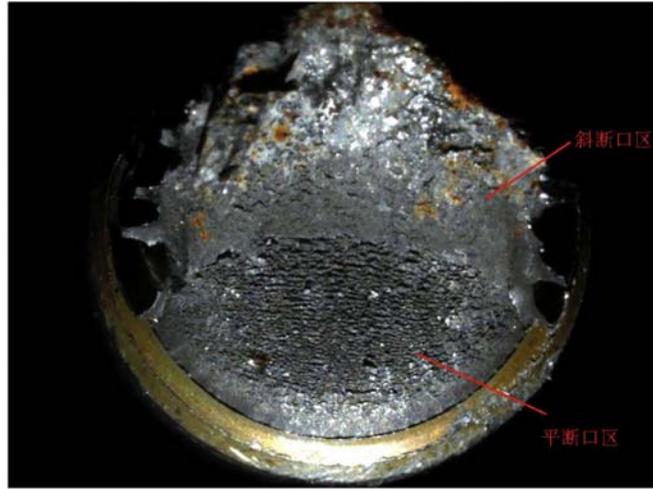
图 15、其中一根螺栓平断口体视显微镜观察形貌

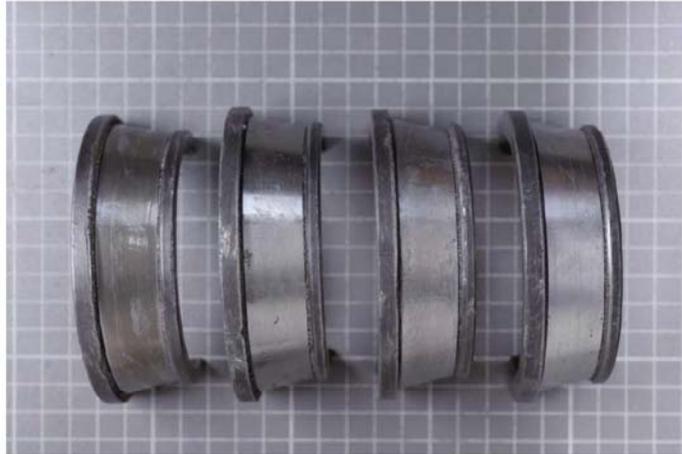
4 个机轮轴承内圈滚道表面形貌如图 16 所示，滚道表面除机械划伤外，无高温变色和金属熔焊特征。3 个分离的轮毂中心毂及安装于其中的机轮轴承外圈形貌如图 17 所示，外圈滚道表面除机械划伤外，同样无高温变色和金属熔焊特征。滚棒形貌如图 18 所示，部分滚棒表面磨损严重，但除一个滚棒端面有熔化和高温特征外，其余滚棒无明显高温变色特征。

图 16、4 个机轮轴承内圈滚道表面形貌

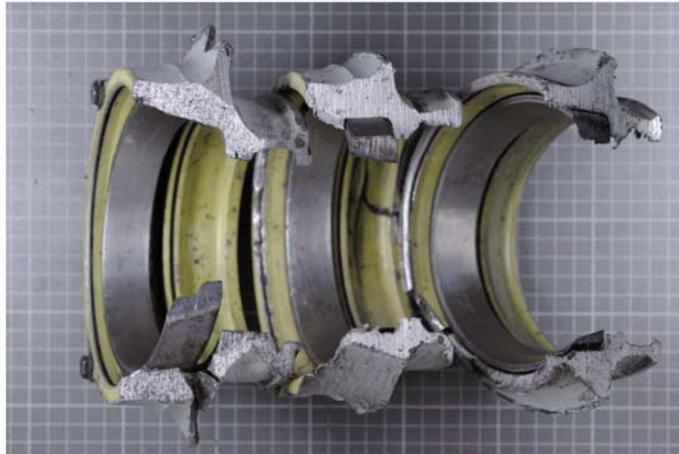
图 17、3 个分离的轮毂中心壳及安装于其中的机轮轴承外圈形貌

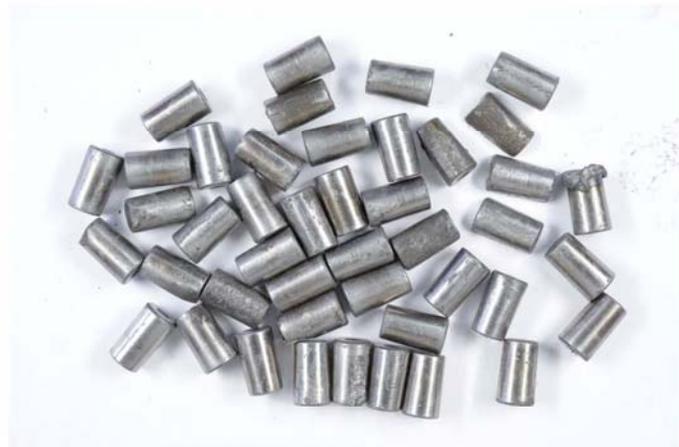
图 18、机轮轴承滚棒形貌

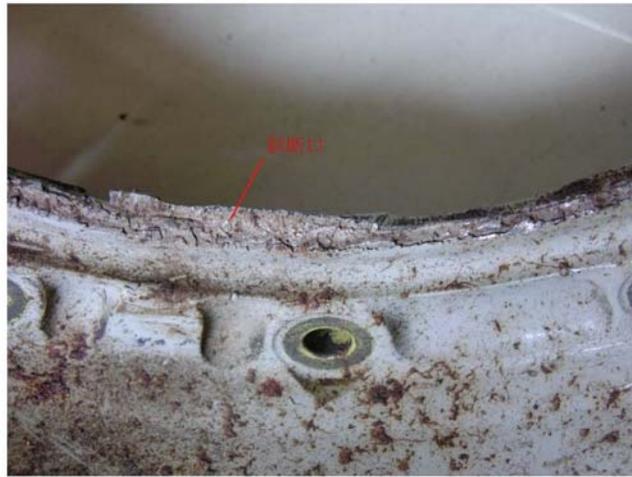
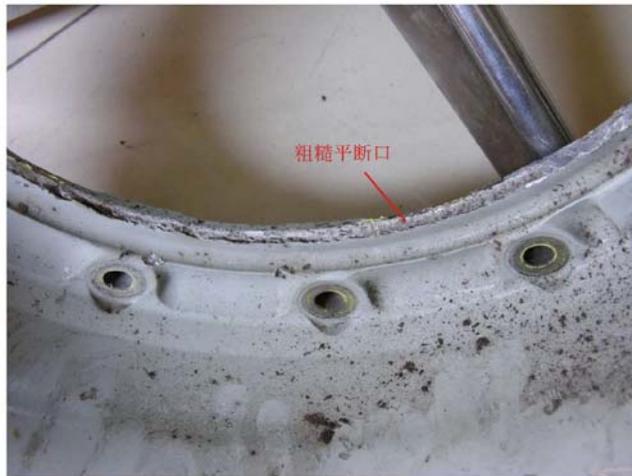
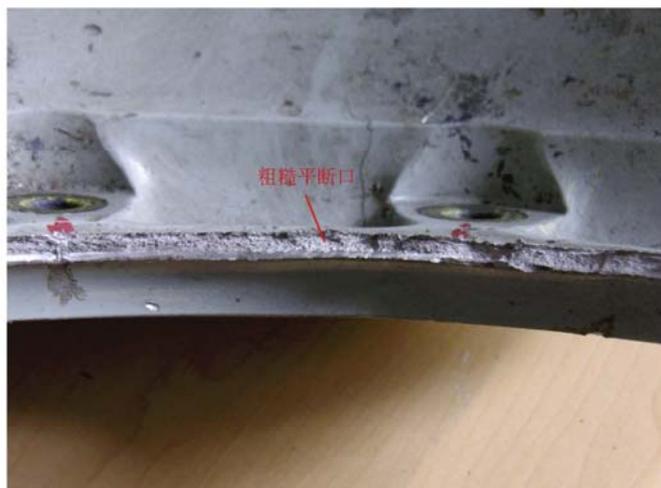
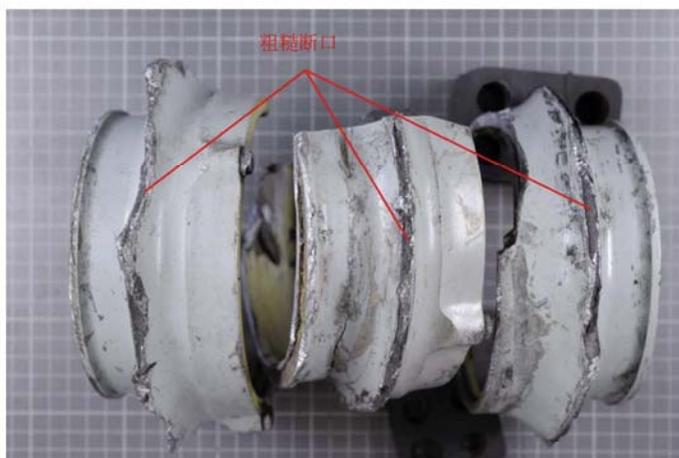
19-22 所示，均为粗糙平断口或较平坦的斜断口，未见平坦光滑的平断口区。全部轮毂辐板碎块的断口也均为粗糙平断口或较平坦的斜断口。发动机中收集到的长 250mm 带螺栓孔的轮毂断裂碎块各个断面形貌如图 23-25 所示，均为粗糙平断口或较平坦斜断口，未见平坦光滑的平断口区。其余轮毂断裂碎块各个断面也均为粗糙平断口或较平坦斜断口，未见平坦光滑的平断口区。

收集到的 3 个半轮毂圆筒、一个半轮毂断裂件、3 个半轮毂中心毂辐板以及全部的辐板碎片、12 根轮毂螺栓的断裂面均为粗糙平断口或较平坦的斜断口，未见平坦光滑的平断口区，这些断口特征显示轮毂的断裂为过载断裂。

图 19、序号为 A7205 的内半轮毂辐板断口形貌

图 20、序号为 A0040 的内半轮毂辐板断口形貌

图 21、序号 A7205 外半轮毂毂辐板断面形貌

图 22、3 个分离的轮毂中心毂辐板断面形貌

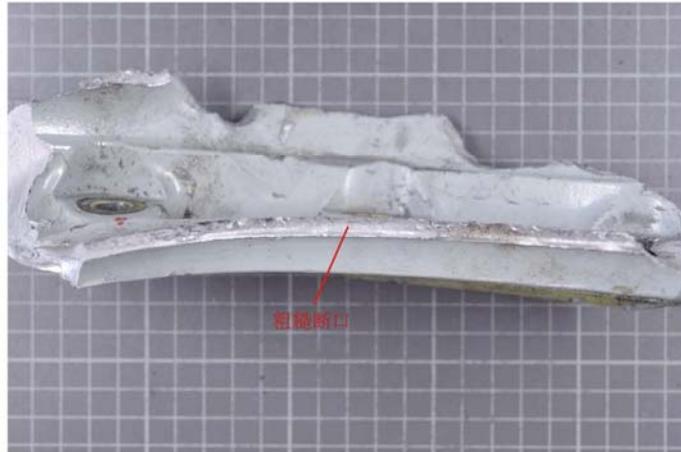
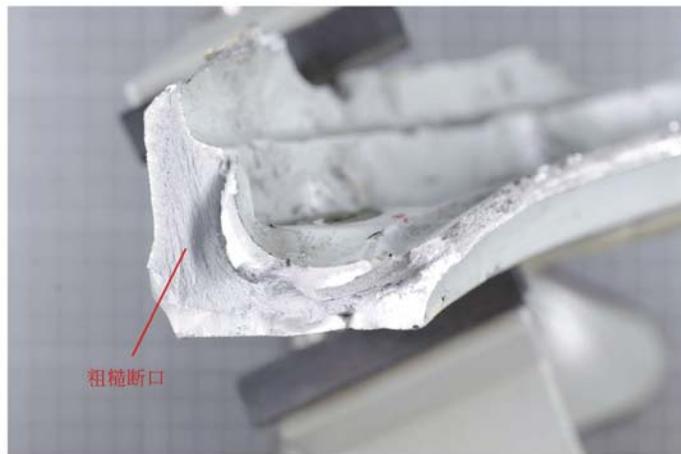
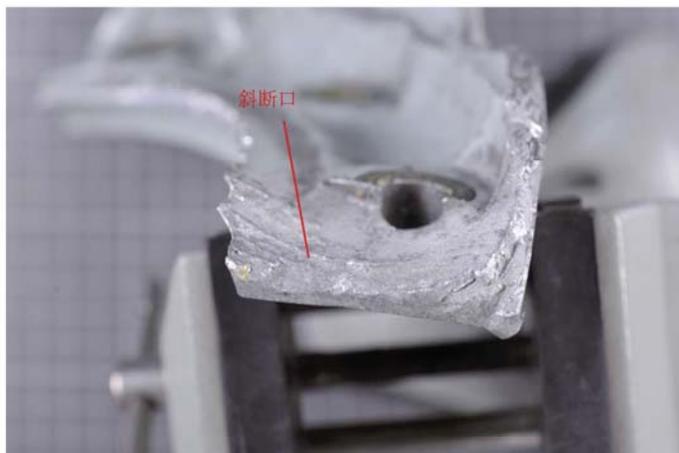
图 23、发动机中收集到的带螺栓孔的轮毂断裂碎块断面形貌

图 24、发动机中收集到的带螺栓孔的轮毂断裂碎块断面形貌

图 25、发动机中收集到的带螺栓孔的轮毂断裂碎块断面形貌

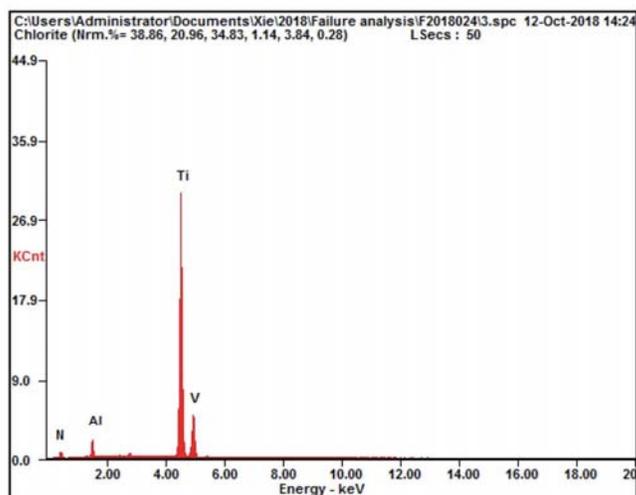
将图 5 所示发动机中收集到的断裂件中 2 个灰暗薄片状碎块进行能谱成分测试，另取 2 个澳门机场跑道收集的灰暗薄片状碎块进行能谱成分测试。此外，在图 5 中箭头所示碎块上取小块材料进行能谱成分测试。4 个灰暗薄片状碎块元素组成相同，其能谱图见图 26，半定量计算结果为 (wt%): 6.72%Al, 3.2%V, 余量为 Ti, 与美国 Ti-6Al-4V 钛合金成分相近。切取的小块材料能谱图见图 27，半定量计算结果为 (wt%): 0.86Mg%, 4.52%Cu, 余量为 Al, 与美国 2017 或 2024 铝合金成分相近。

图 26、发动机中收集的 2 个灰暗薄片状碎块能谱图

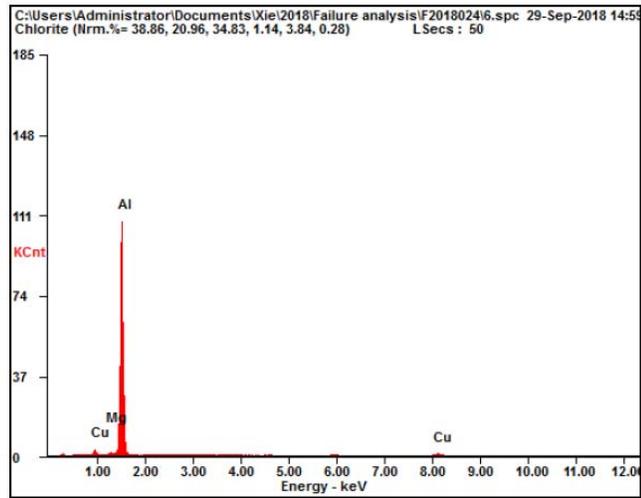
图 27、发动机中收集的块状碎块上切取的小块材料能谱图
