**Aircraft Incident Report 01/05**

**Civil Aviation Authority  
Macao, China**

**Report on the ground incident to B747-400 and CRJ-700 at Macau  
International Airport on 16 September 2005**

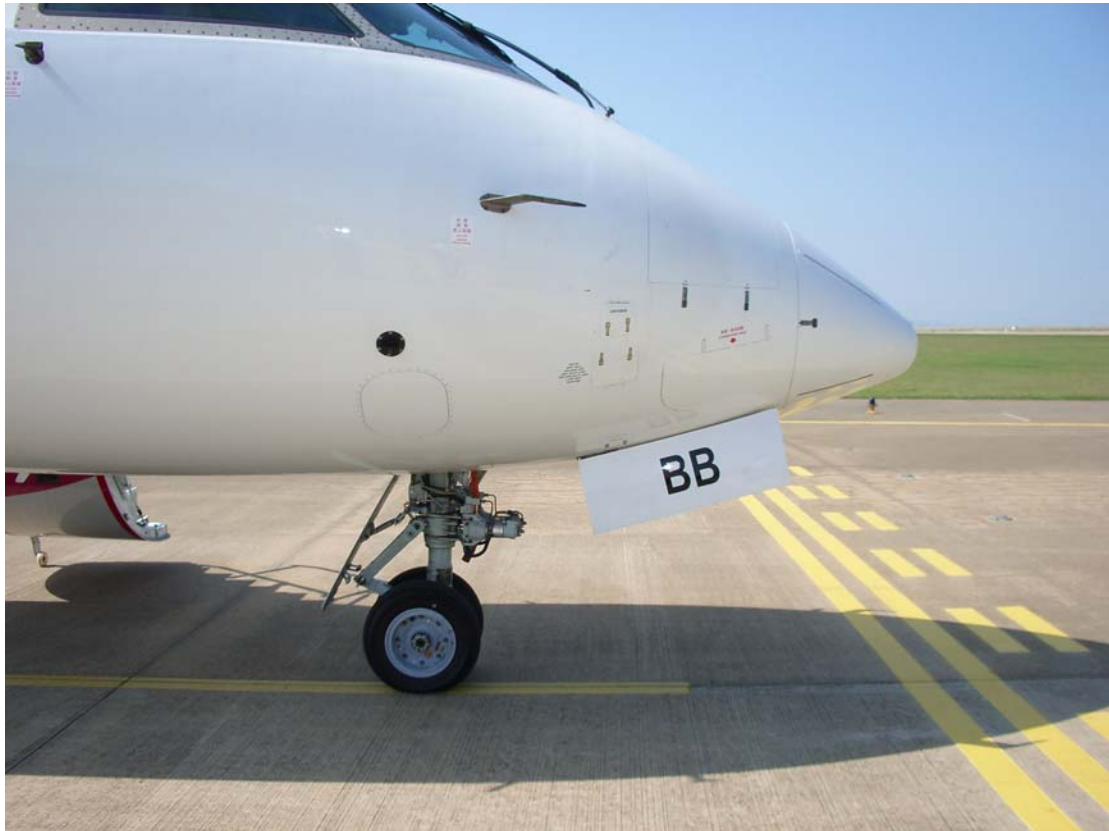
After the ATC approved the CRJ to depart via intersection D and instructed the CRJ short runway 34, the CRJ has held short at intersection D in front of the stop bar. (See Figure 1 & 2).

Figure 1. CRJ hold short position at intersection D (Side View)

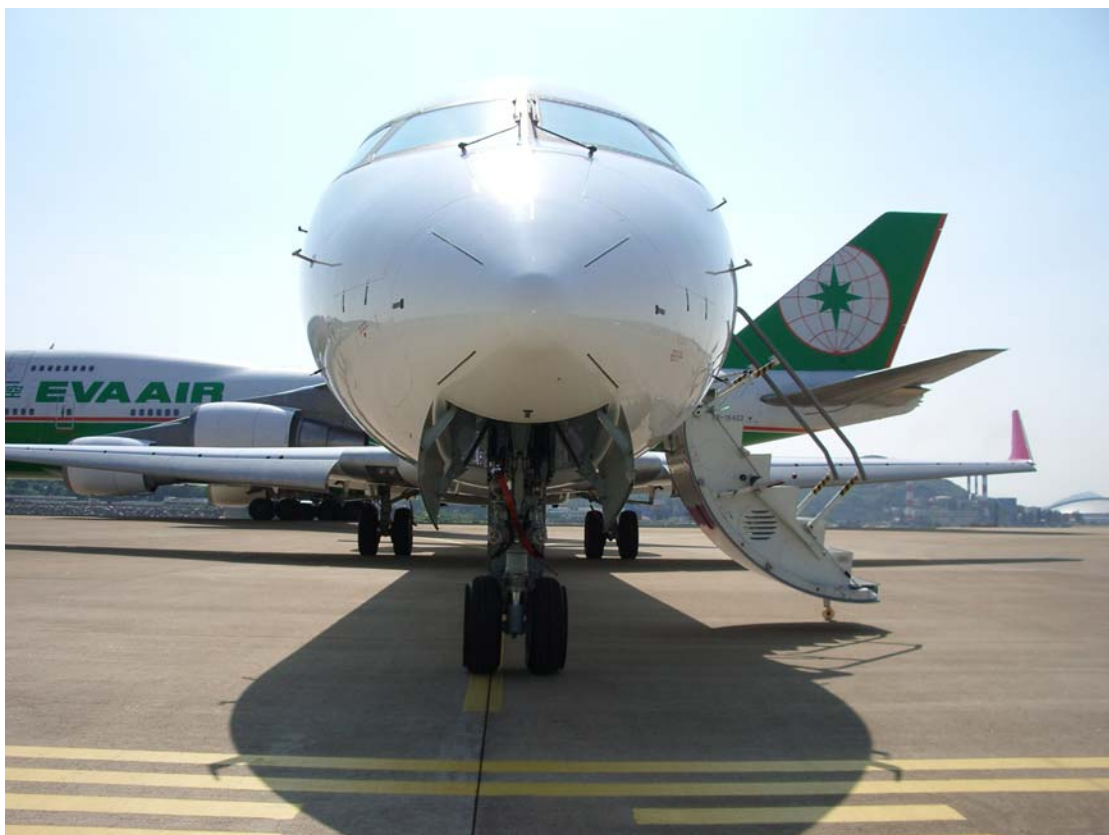
Figure 2. CRJ hold short position at intersection D (Front View)

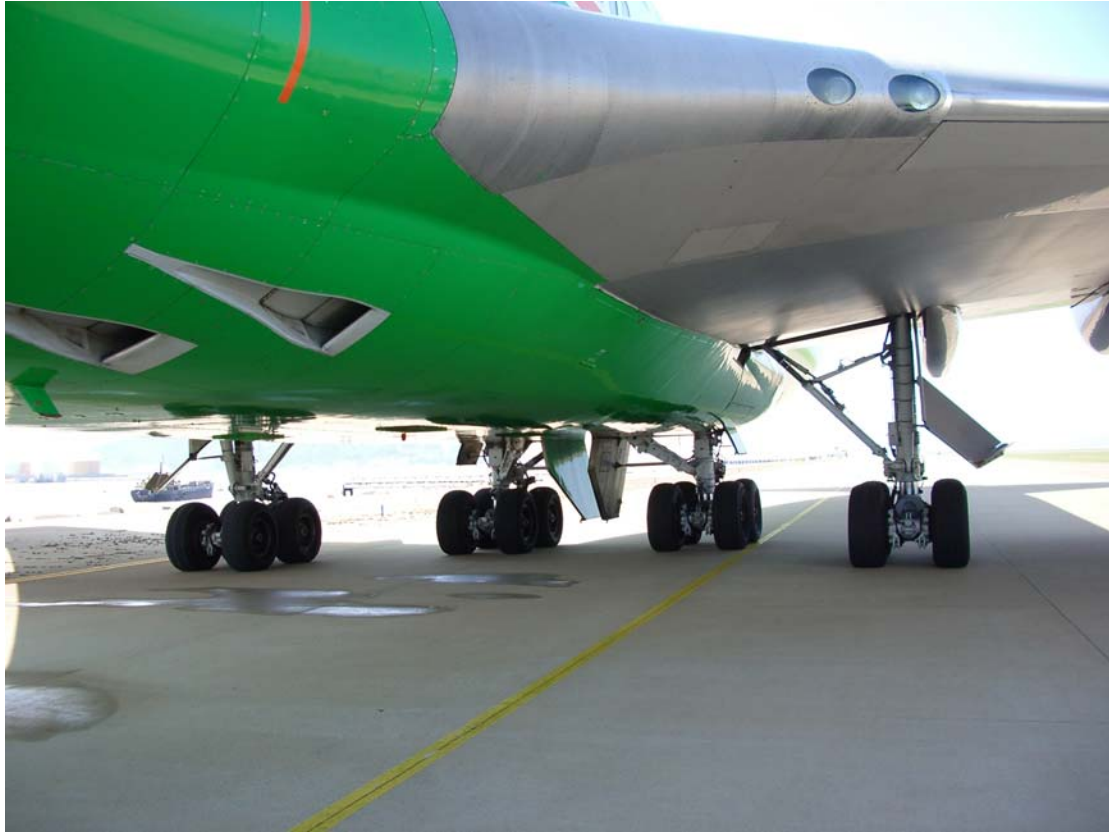
At the point of contact, the B747 was 3.6 meters right from the taxiway centerline. (See Figure 3 to 5)

Figure 3. B747 stopped position after the impact. (Main Landing Gear)

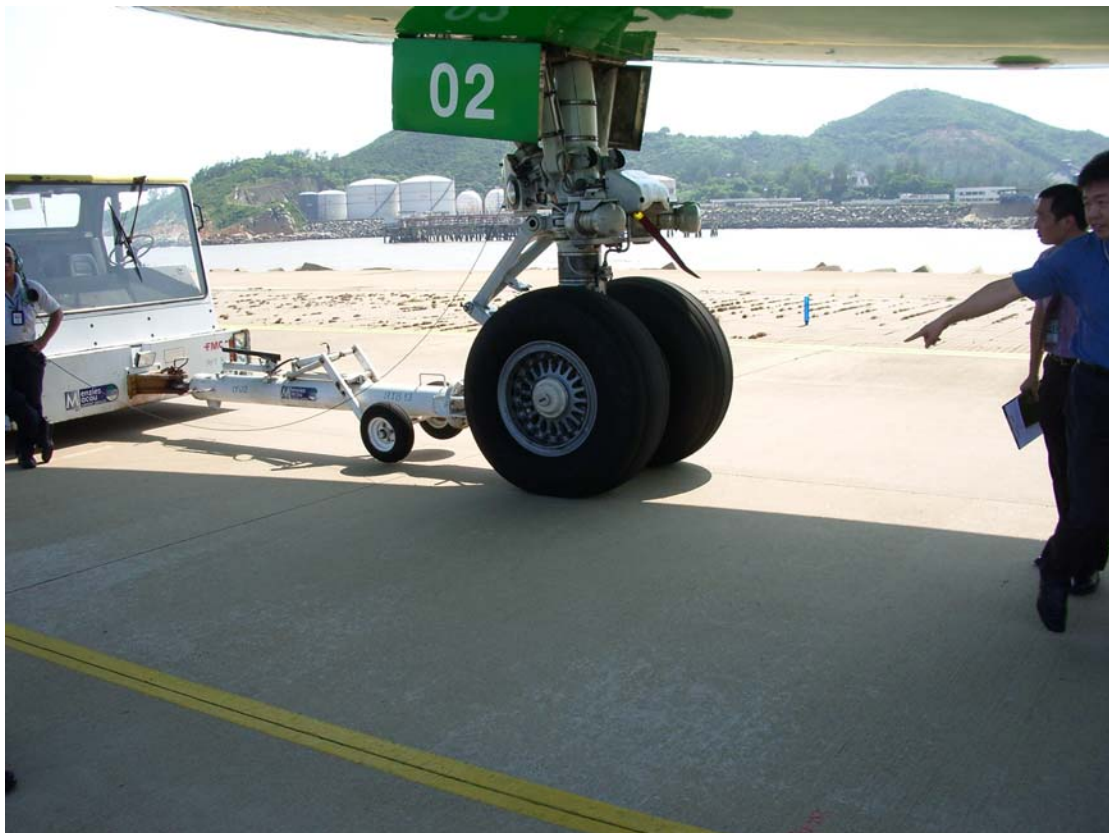
Figure 4. B747 stopped position after the impact. (Nose Wheel)

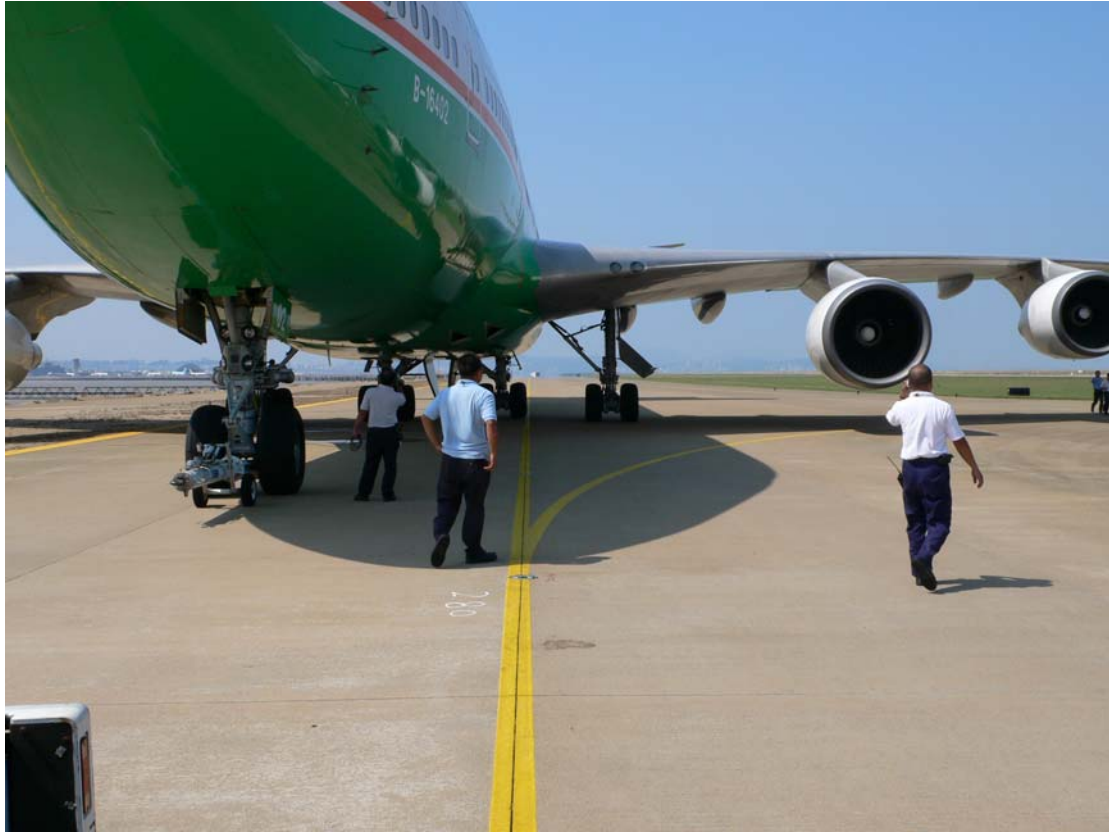
The misjudgment of spatial clearance by the taxiing B747 caused this incident. The PIC of the B747 made his judgment based on using the CRJ tail cone instead of using the CRJ horizontal stabilizer as his visual cue.

Figure 5. B747 stopped position after the impact. (Front View)

There is a procedural error that the taxiing aircraft deviating from the taxiway centerline. It is recommended that the operator of the B747 to strengthen the training on the standards operations procedures on taxiing including threat and error management.

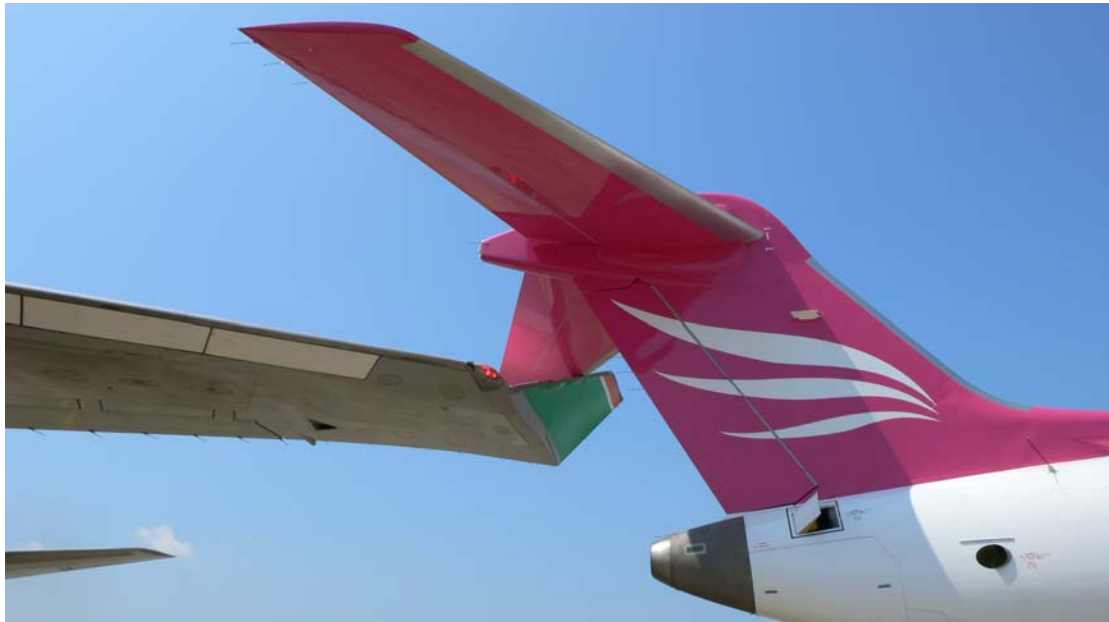
Figure 6. The impact.

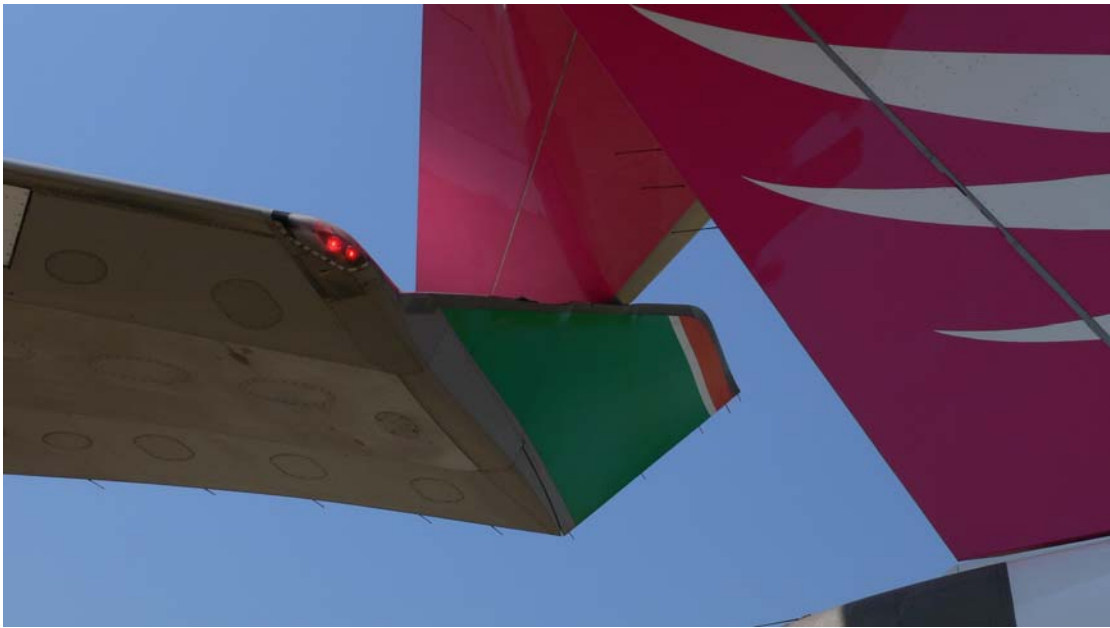
Figure 7. The impact.

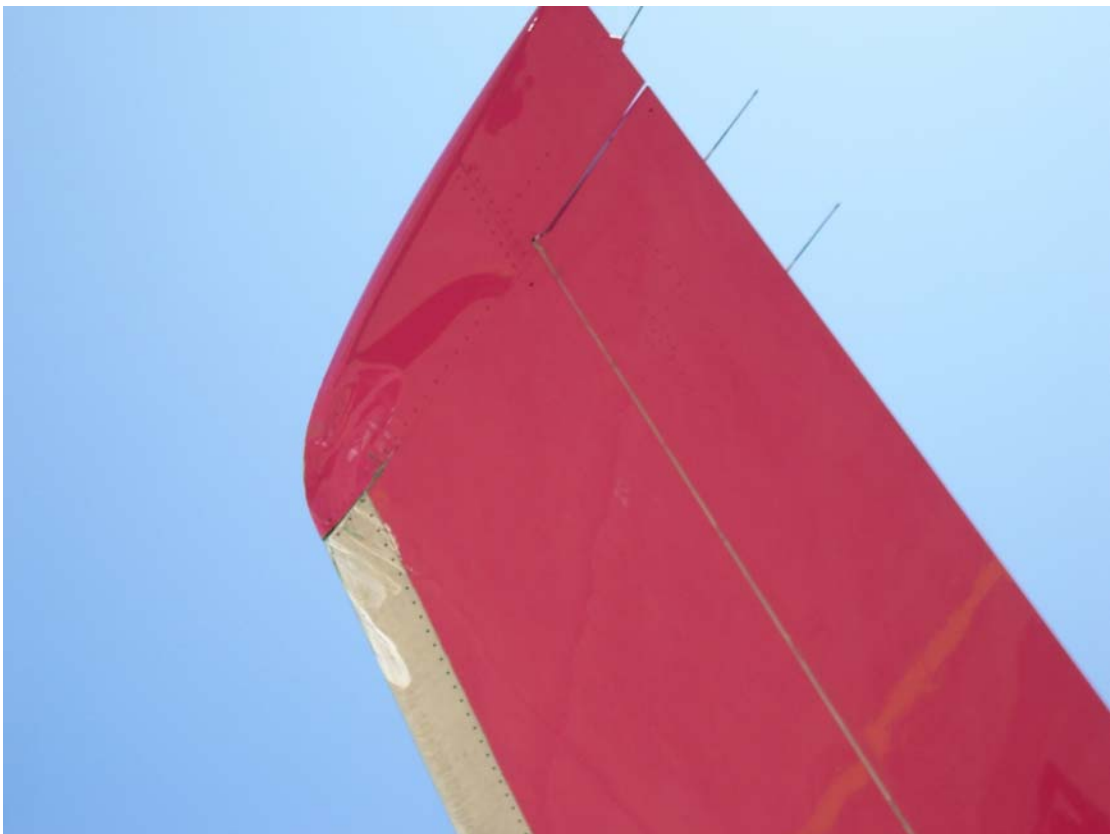
- The left horizontal stabilizer tip forward fairing was deformed at the forward and lower side; the fairing mounting straps were found broken and cracked at the forward and outboard of the fairing;
- The left horizontal stabilizer lower skin was found scratched;
- The leading edge of left stabilizer has been scratched and dented with outline about 2.5" X 14", the maximum depth is 3/8"; and
- The left horizontal stabilizer leading edge rib No. 20 was found cracked.

Figure 8. Graze on the left horizontal stabilizer of B-KBB.

A temporary repair was carried out in Macau International Airport and the CRJ-700 positioned back to Hong Kong at 0751 UTC on 19 September 2005.

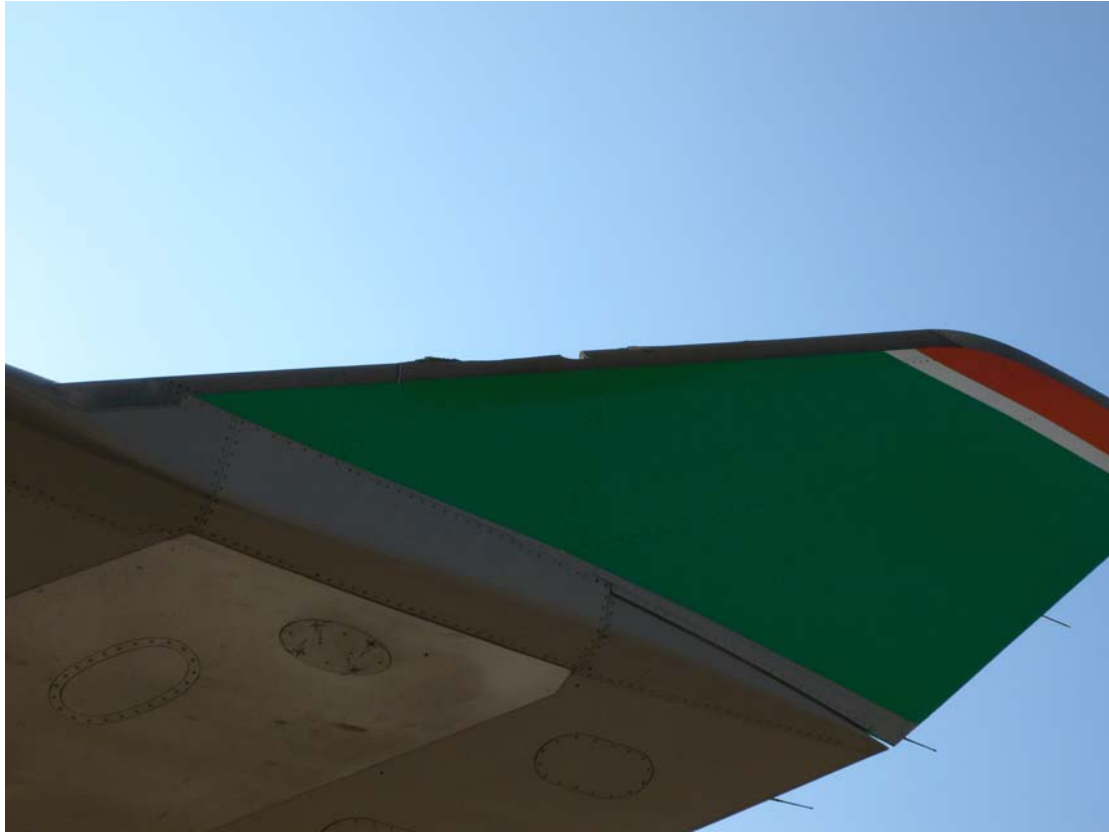
Damage to B747 was limited to left winglet. Winglet leading edge was found with skin crack and twist. Leading edge joint strap and ribs were found deformed and cracked.

Figure 9. The damage to the left winglet leading edge of B-16402

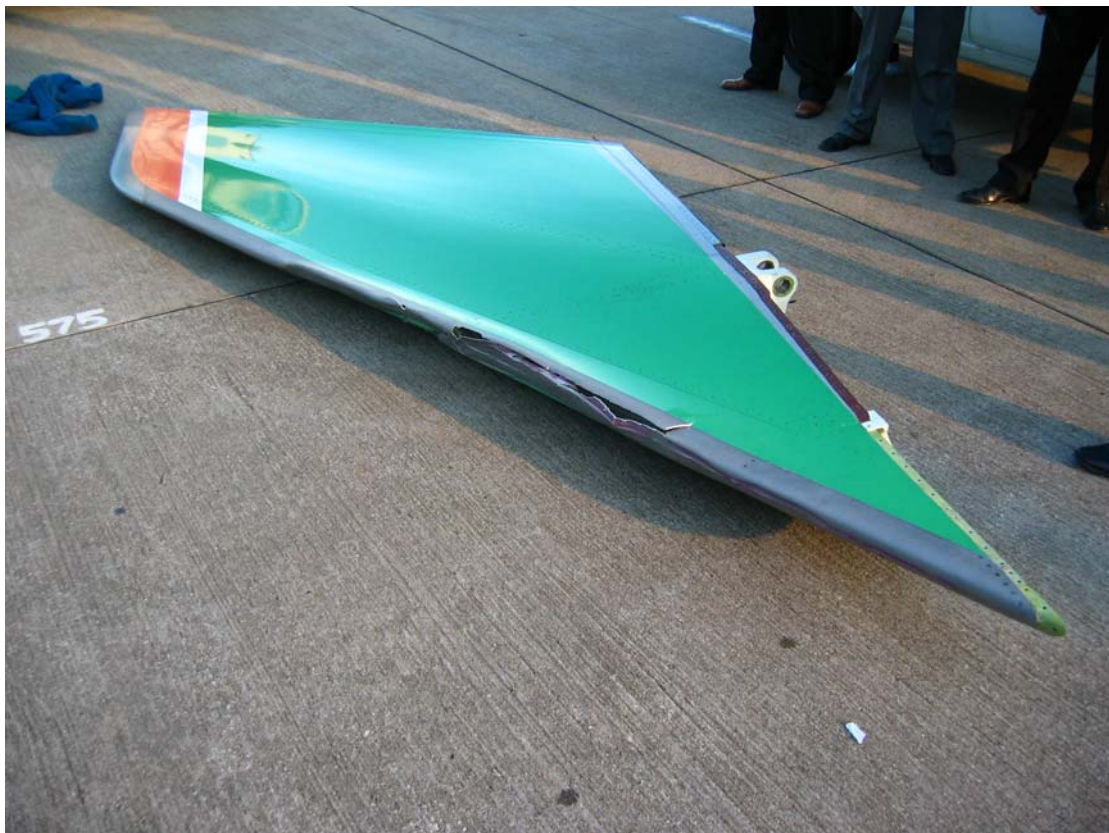
The Minimum Equipment List (MEL) of the B747 permits flight with one winglet removed. The B747 departed at 1051UTC on the same day.

Figure 10. Removed left winglet from B-16402

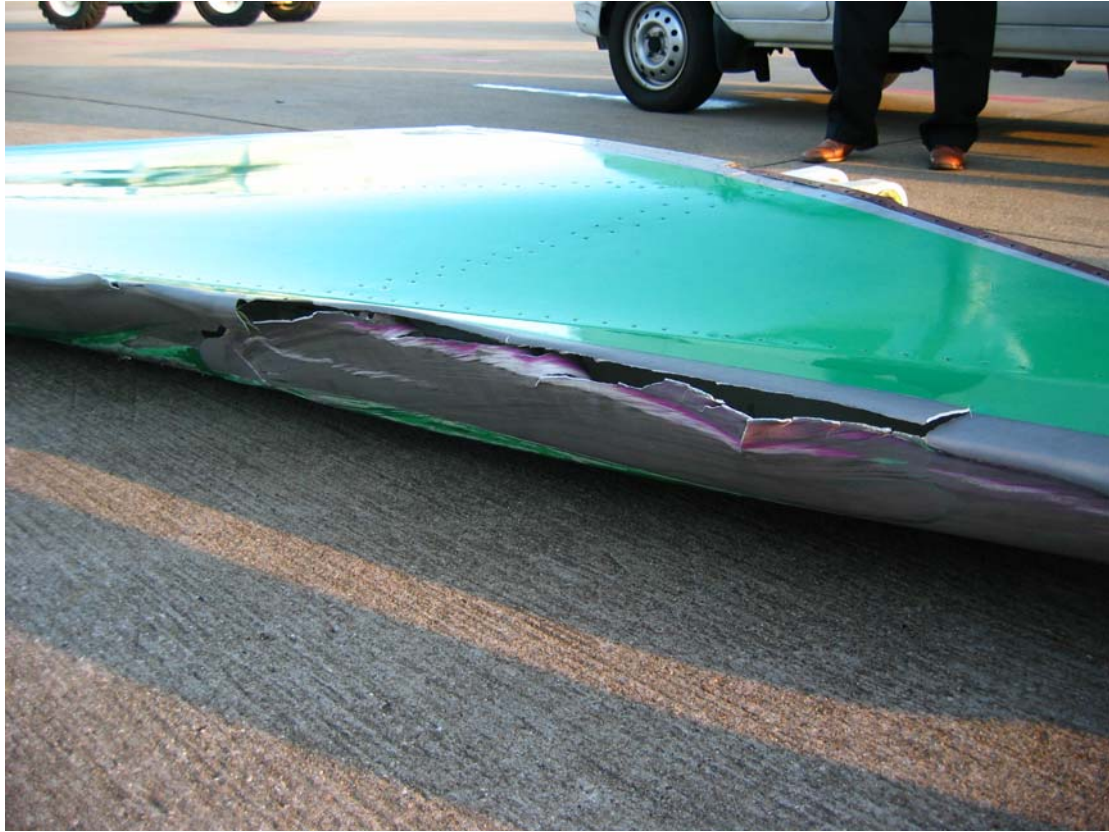
Figure 11. The damage to the left winglet of B-16402
