ACCIDENT INVESTIGATION REPORT

AIRCRAFT ACCIDENT No. ACCID01/06

Report on the accident to Airbus A321 during push back at

Macau International Airport on 4th March 2006

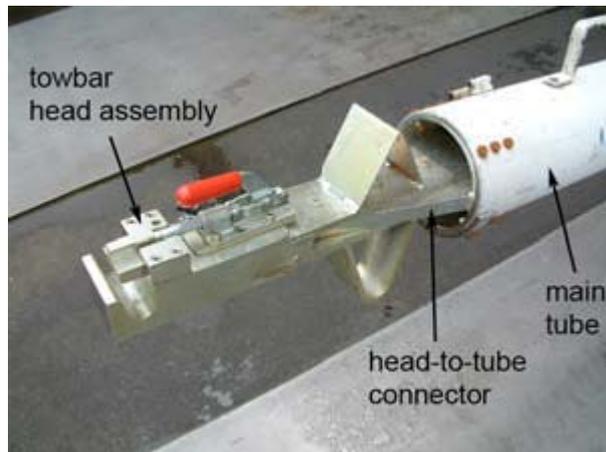
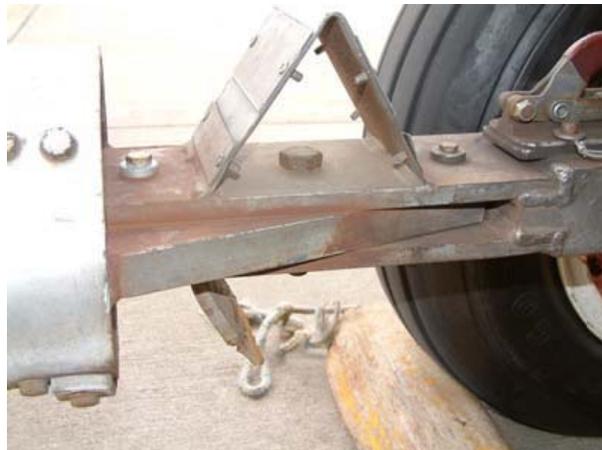
Figure 1.4.1 and 1.4.2 above shows a towbar of the same model. The towbar head assembly is attached to the main tube through the head-to-tube connector by three bolts. The bolts at the two ends were shear bolts. The middle one is fitted into a hole larger than a normal bolt hole, so that

during operation, the shear load is transmitted through the two shear bolts. The middle bolt is of size of about 16 mm in diameter, and will take the shear load when the two shear bolt fail. The function of the shear bolts is to act as a safeguard against turning too abruptly, or at an angle which is too sharp during the pushback operation.

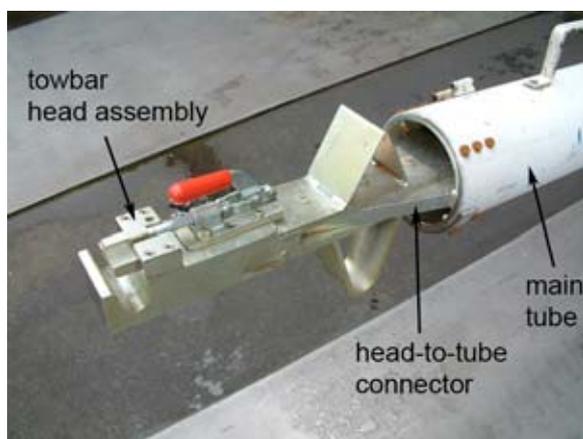
(a) a new towbar head assembly

Figure 2-1(a) shows a new head assembly of a towbar. One end of the head assembly consists of a U-channel with a half round shape at the bottom to receive the towbar fitting attached to the nose undercarriage. The other end consists of two parallel plates for connection to the head-to-tube assembly, which in turn connects to the main tube of the towbar with 12 bolts. The connection between the head assembly and the head-to-tube connector is with two shear bolts at either end, and a loosely fitted bolt of about 16 mm in diameter. This will be described in better details in Section 3. Figure 2-1(b) shows the towbar involved in the incident. In comparison with the new towbar head assembly, it can be seen that the top of the two parallel plates is broken off from the main body near its welded joint. Also, the bottom plate was bent by about 110°. Nearly all of the bolts attaching the locking mechanism on the top of the head assembly were broken.

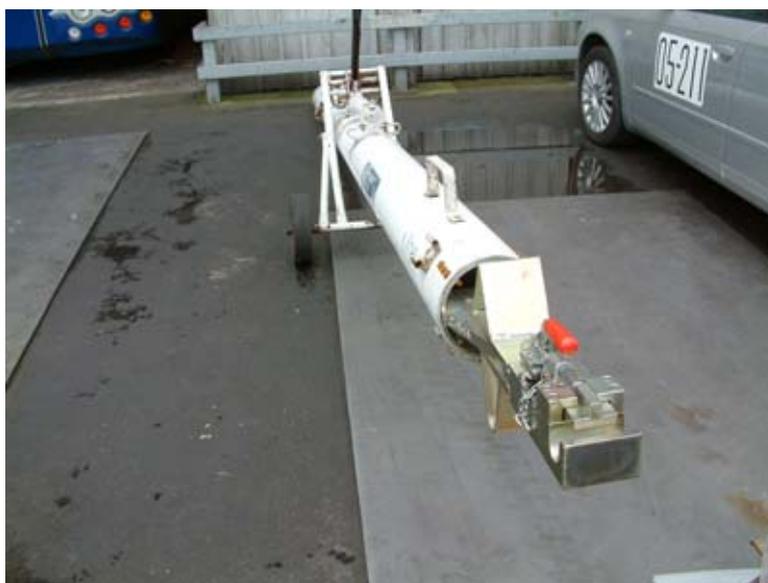
Figure 3-1 : The incident towbar fitted with a new head assembly

Figures 2-1(a) and 3-1 show the incident towbar fitted with a new head assembly. So although the head assembly and the head-to-tube connector were damaged, the remaining parts of the towbar were serviceable. In particular, the main tube and the positions for the bolts as shown in Figure 2-1(a) were in good condition, and so the fitting of a new head-to-tube connector and head assembly was possible. In other words, the damage to the towbar in this case was to the head-to-tube connector and head assembly only.

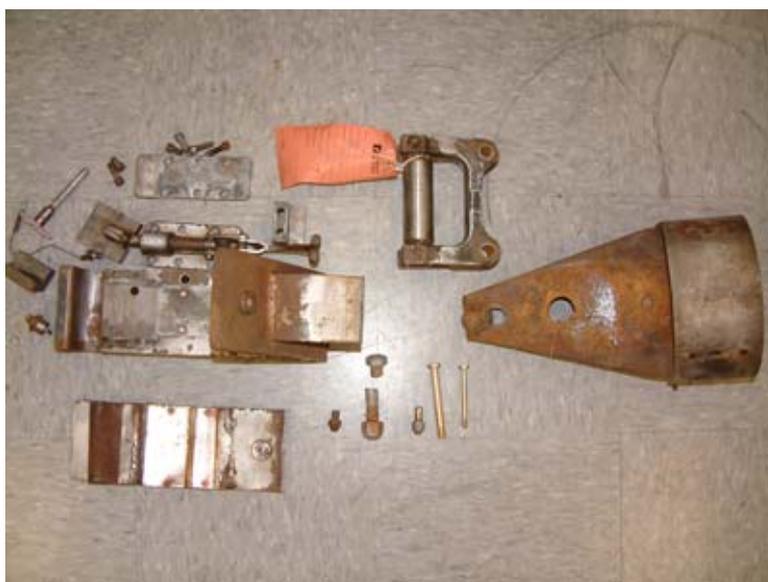
Figure 4-1 : Samples as received from Menzies

The samples, having been identified during the site visit, were transported to the investigator at City University of Hong Kong for detail examination. Figure 4-1 shows the samples as received from Menzies. Apart from the pieces from the head assembly, the samples also consist of the towbar fitting on loan from Air Macau and the head-to-tube connector. Two new shear bolts were also provided for comparison. It is noted that at a later stage, three bolts of about 16 mm (5/8-inch) in diameter were also provided by Menzies for tensile test.

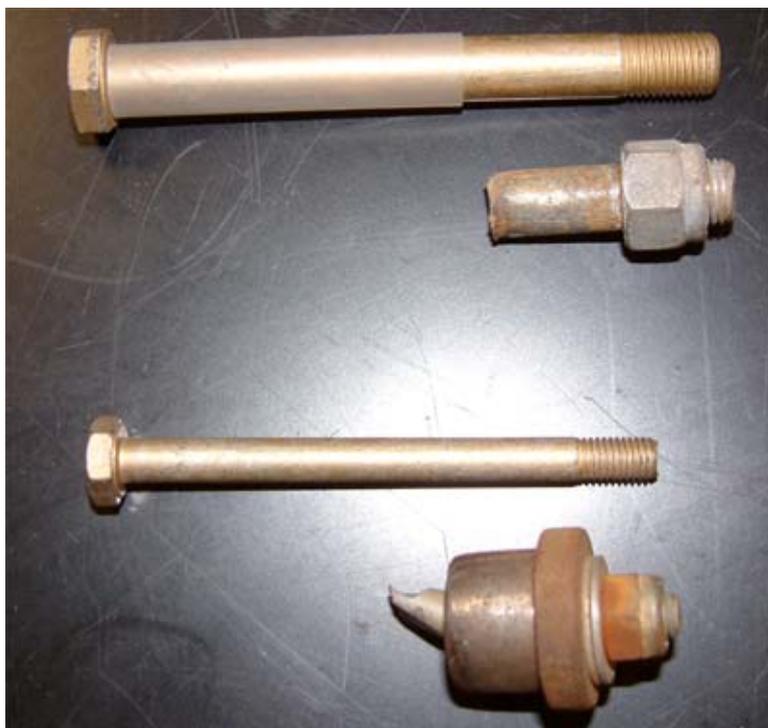
Figure 4-16 : Large and small shear bolts

Figure 4-16 shows new large and small shear bolts, as well as the remains of the shear bolts from the incident.

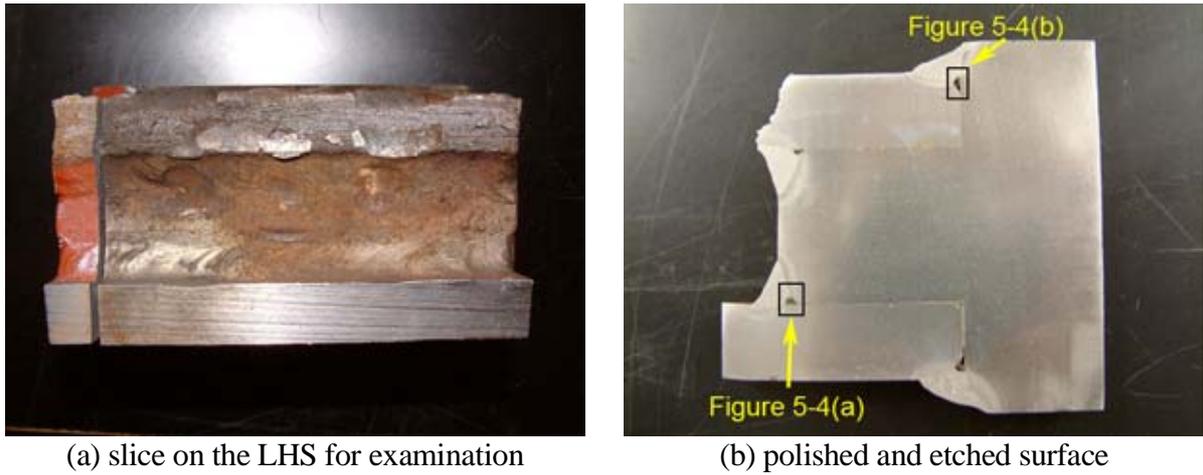
Figure 5-3 : Cross-section sample for examination of welded joints

The head assembly is made from a metal block, welded with two horizontal plates. The welded joint of the head assembly was first sectioned at an appropriate location, as shown in Figure 5-3(a). Grinding, polishing and etching were carried out as shown in Figure 5-3(b), so as to reveal the microstructure. Figures 5-4(a) and 5-4(b) show typical microstructures at welded joints. They both show good weld interfaces between weld metal and metal block or plate.
