Aviation Occurrence Investigation

Final Report

INCID/01/2018

Aircraft Damage Caused by Hard Landing

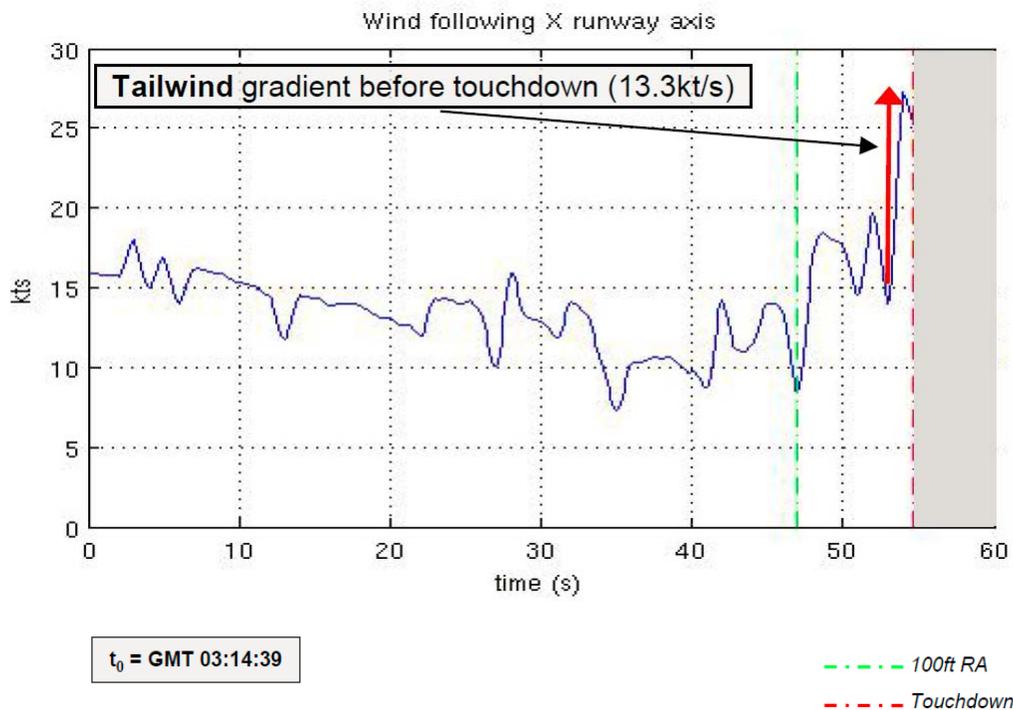
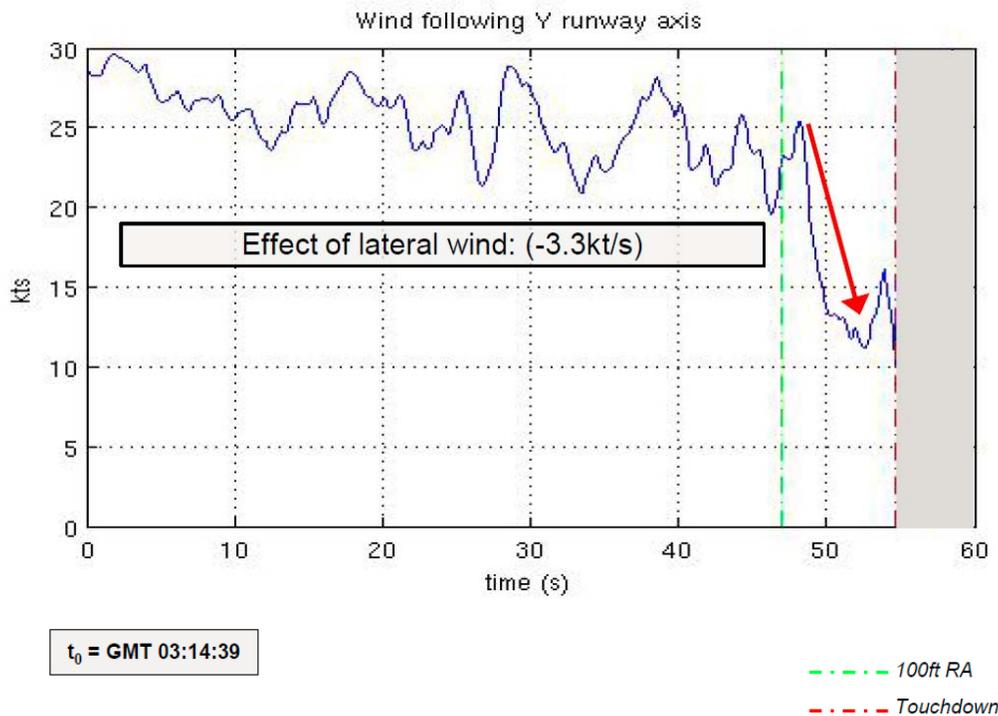
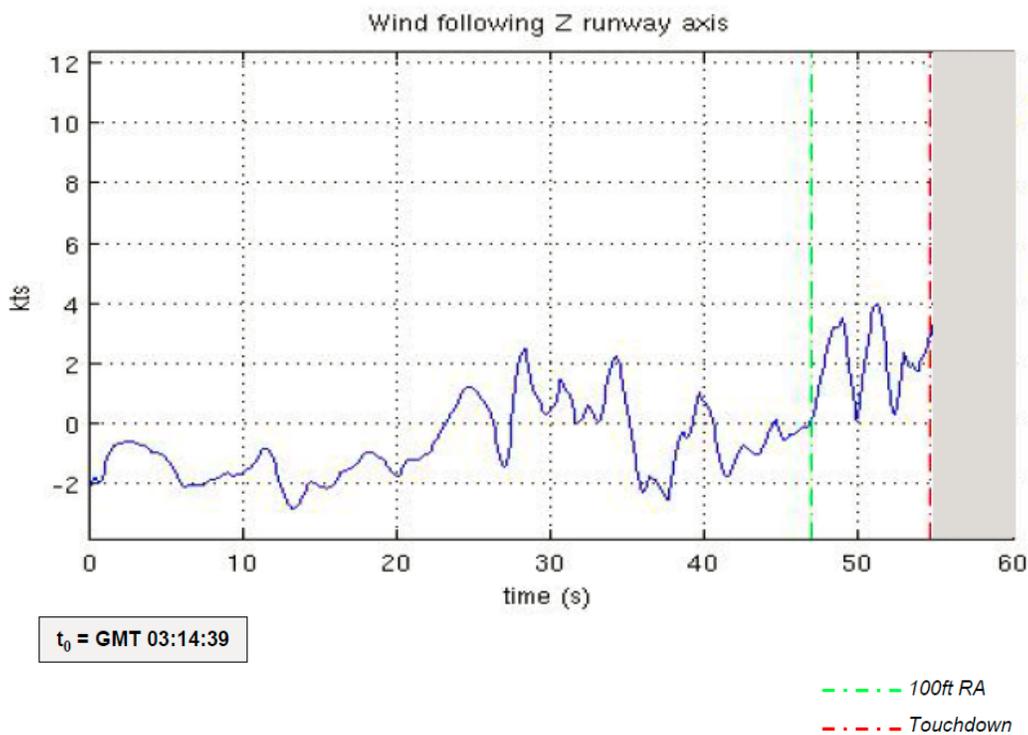
Wind Reconstruction

Wind reconstruction shows:

- Tailwind increasing gradient of approximately 13kt/s between 19ft RA and the touchdown.
- Lateral gradient (3.3kt/s) between 88ft RA and the touchdown.
- Vertical windshear below 100ft with downdraft tendency.
